June 18, 2010

Outline

- Analysis of annealed VCSELs after irradiation
- Investigation of Optowell PINs leakage current problem
- Gathering storm on opto-boards of current pixel detector
- Summary

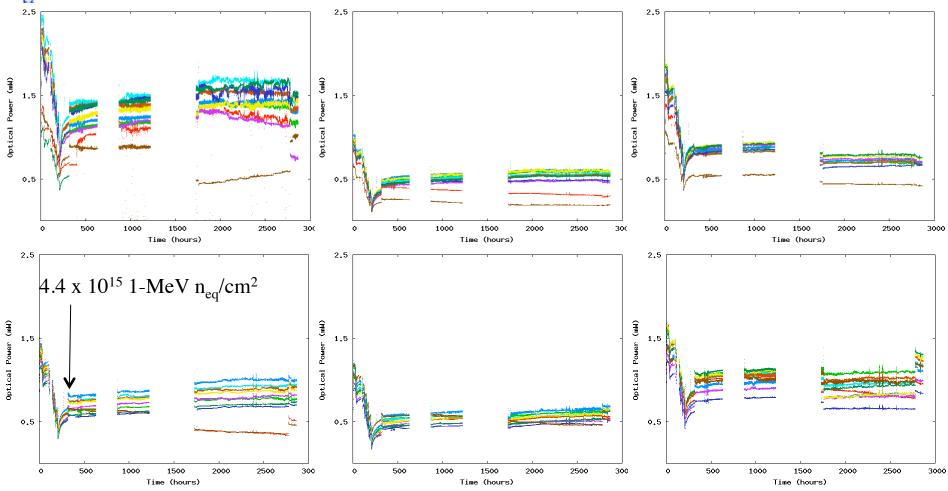
AOC 10 Gb/s VCSEL

Reasonable optical power for 6 arrays irradiated

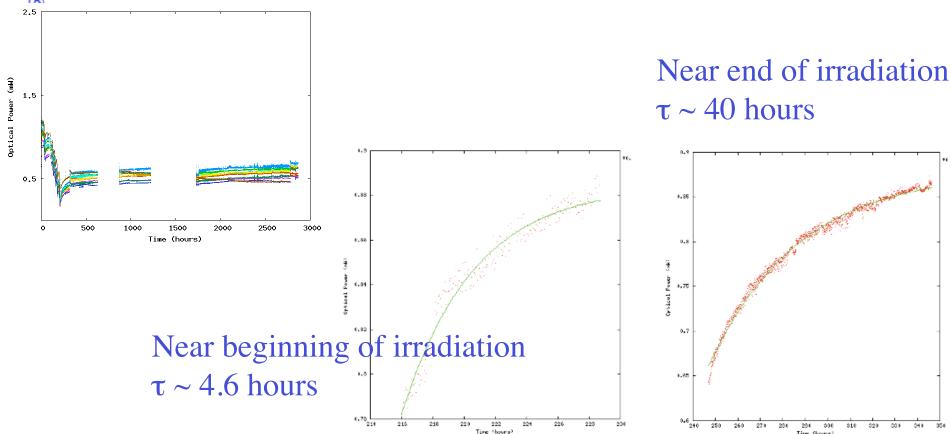
Power Recovery Time vs Dosage

- Fit power vs time during annealing to exponential function
 - ⇒ recovery time increases with dosage
 - do not fully regain the lost power
 K.K. Gan
 IBL General Meeting

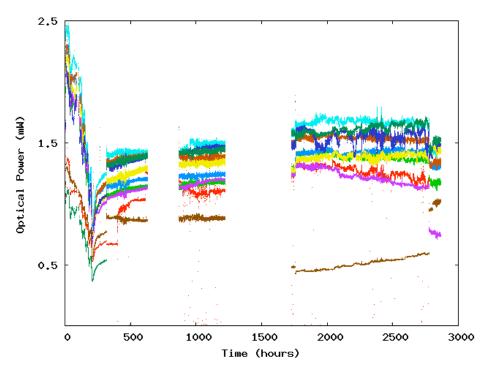
AOC 10 Gb/s VCSEL

- One channel produces no power
 - ⇒ need further investigation
- Power of several channels decrease with time
 - ⇒ need further investigation
- Plan to irradiate a sample of 20 arrays in August 2010

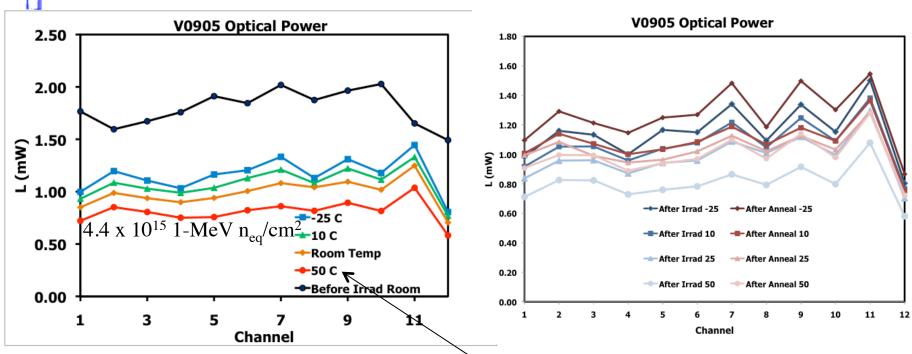
VCSEL Power vs Temperature

Ambient temperature VCSEL temperature is 8 C higher

- Cooler VCSEL produces more optical power
 - Same characteristic after irradiation and annealing

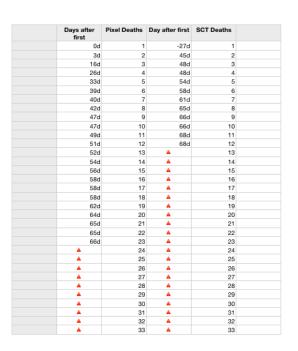
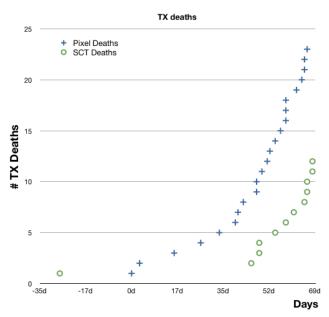
TX Problem

- VCSEL arrays on off-detector TX of Pixel and SCT are dying at alarming rate in 2008
 - ⇒ replacement of all TXs in 2009
 - new TXs starts to die again in April 2010
