# Status of Opto-Board Production/Postmortem

K.K. Gan, R. Ishmukhametov, H. Kagan, R.D. Kass,  
J. Moss, J. Moore, S. Smith, B. Tannenwald, Y. Yang  
The Ohio State University

June 12, 2013

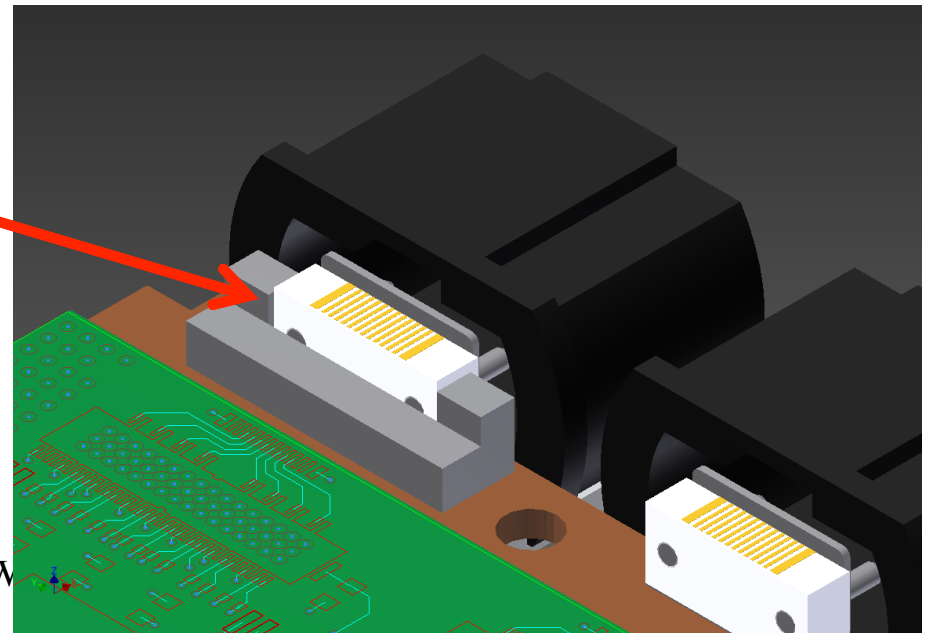
- Several opto-packs detached at various stages of production
  - ⇒ detailed investigations + discussion with epoxy vendor
  - ⇒ no obvious causes of failure found
  - ⇒ two improvements:
    - ◆ scoring of PCB surface to improve adhesion
    - ◆ add aluminum brace to greatly increase epoxy contact area
      - ⇒ cannot remove opto-pack without destroying opto-pack

Sandblasted surfaces  
to improve adhesion

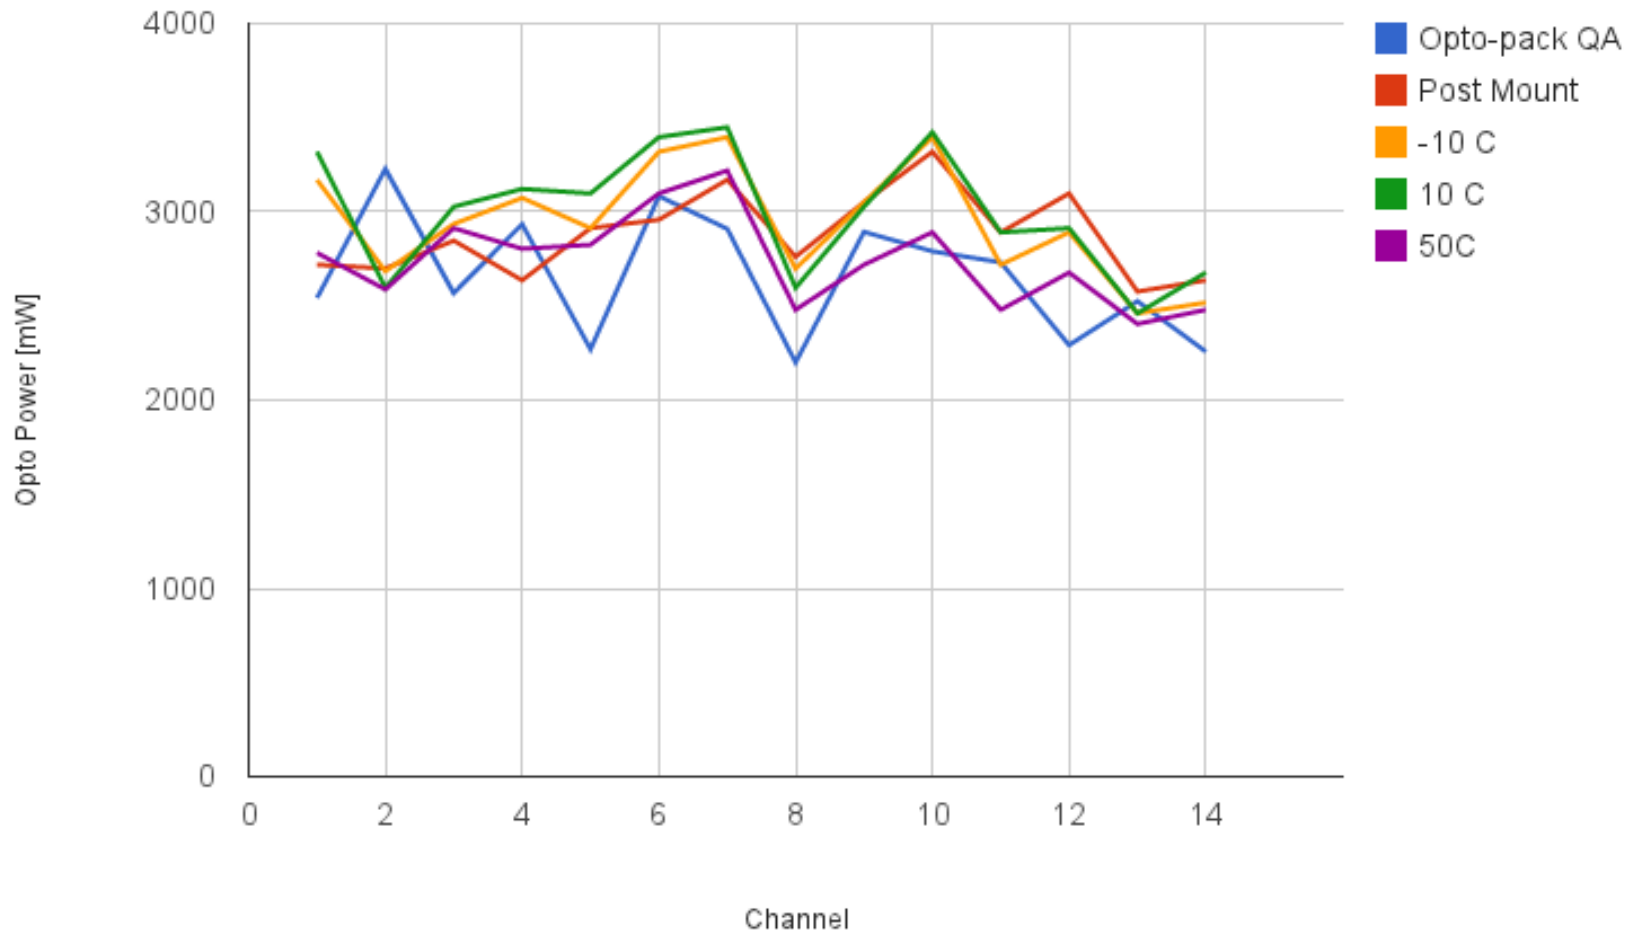
D4013

● Excellent optical power!!!
