# Status of On-Detector Opto-Links

K.K. Gan, H. Kagan, R.D. Kass,  
J. Moore, D. Pignotti, S. Smith  
The Ohio State University

October 12, 2012

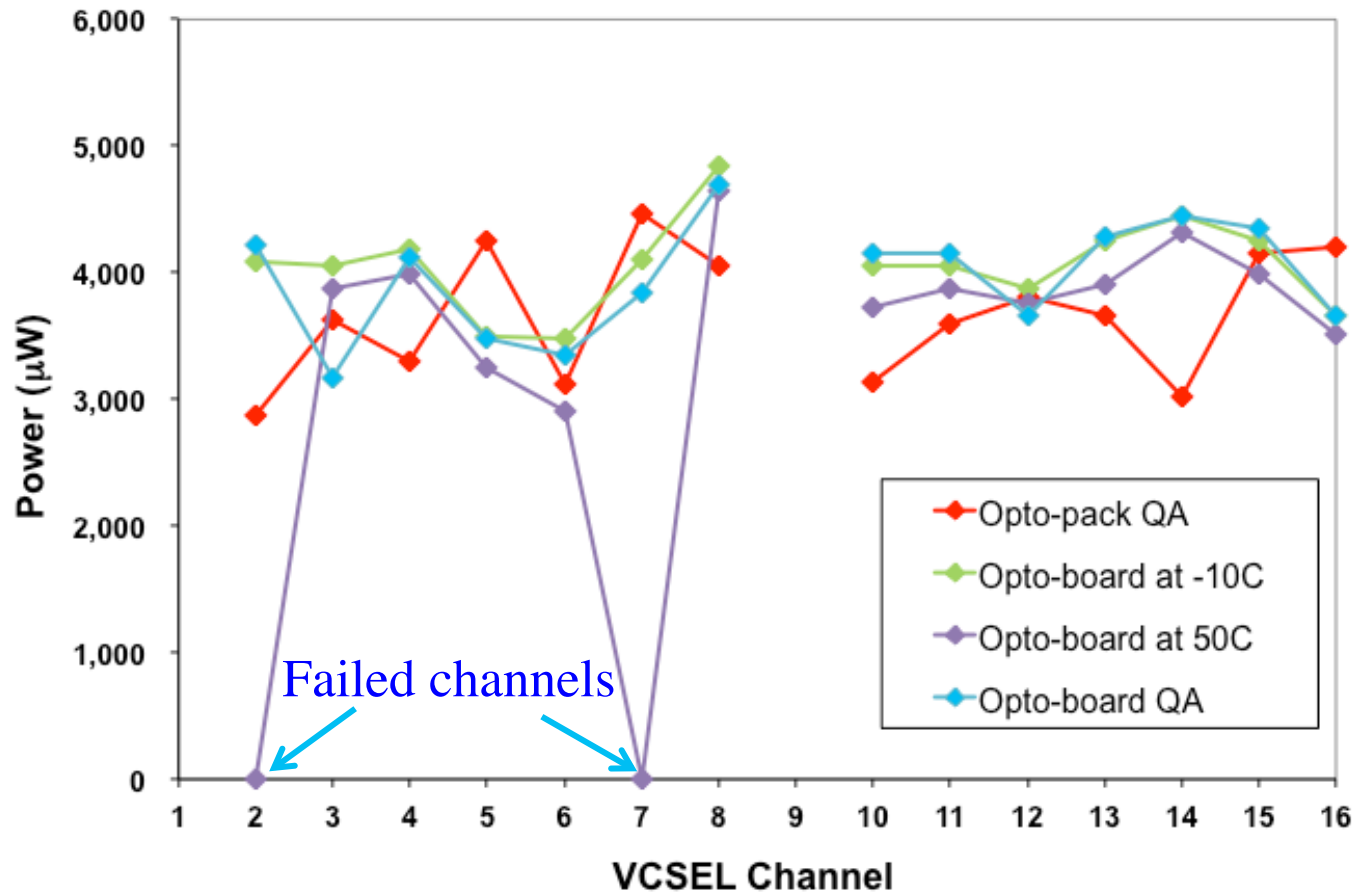
- Excellent optical power but two channels failed

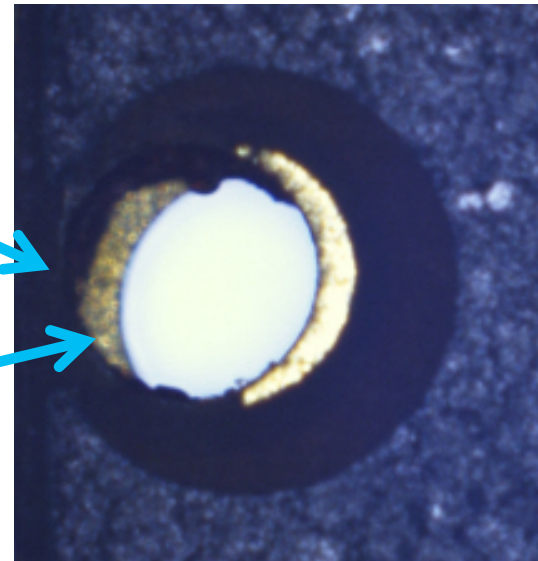
- VVDC/GND shorts on 6 of the 25 boards
  - ◆ shorts removable by high current/mechanical scraping
  - ◆ caused by problems with large hole drilling
- Problems at passive assembly house caused by misalignment between the copper plate holes and PCB holes
  - ◆ the connector would not sit flat
    - ⇒ should drill bigger holes on copper plate

PCB drill hole shifted

Copper plate not aligned

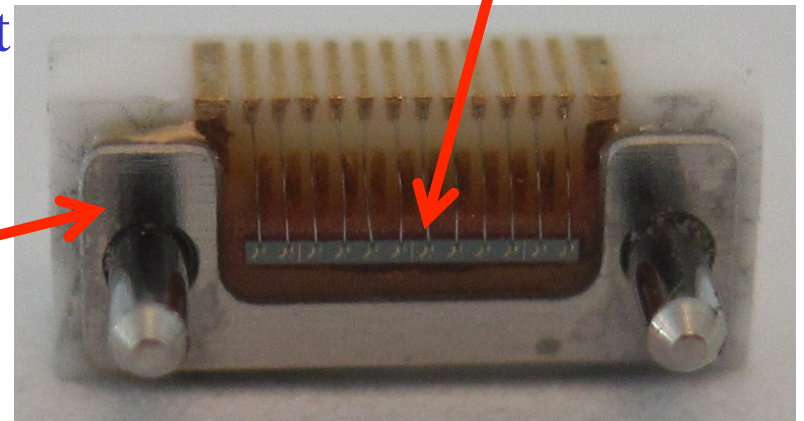
- VCSEL array mounted on opto-pack should survive at least 1,000 hours at 85 C and 85% humidity
  - to qualify two vendors: ULM and Finisar
- IBL GM, June 2012:
  - 20 ULM arrays survived to 1,000 hours
  - analysis of failed arrays after 1,000 hours
    - ◆ scrapping of optical epoxy wicked up guide pins might cause mechanical stress
      - ⇒ use dam for epoxy containment

dam

array

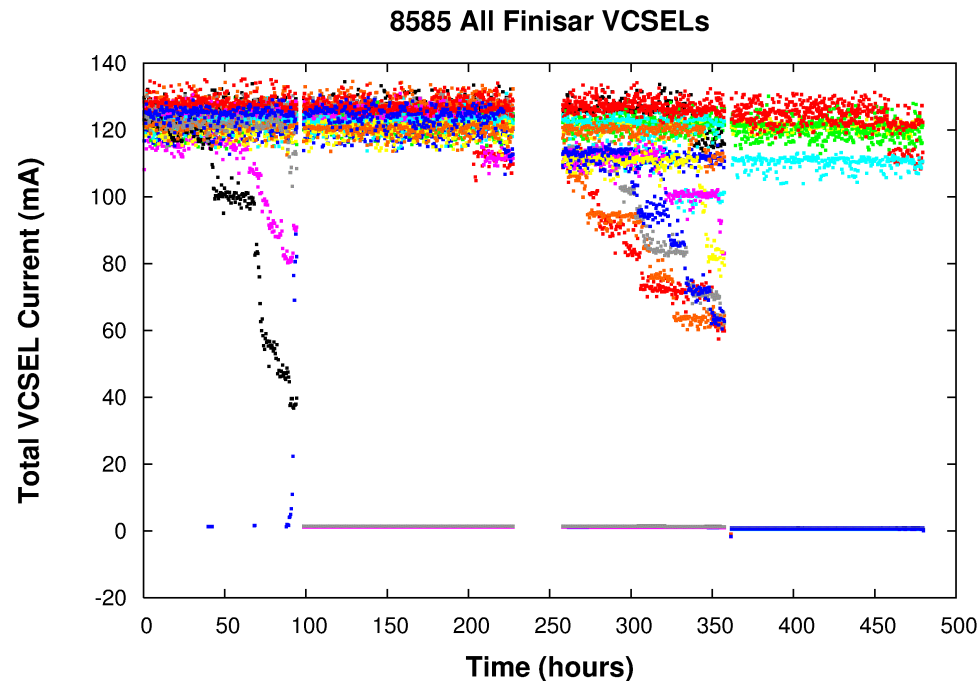
- Sept 2012:
  - loaded 20 VCSEL arrays
  - fibers inserted during test to exert connector spring force
  - after 50 hours: channels on 4 arrays failed
  - after 250 hours: channels on 10 additional arrays failed

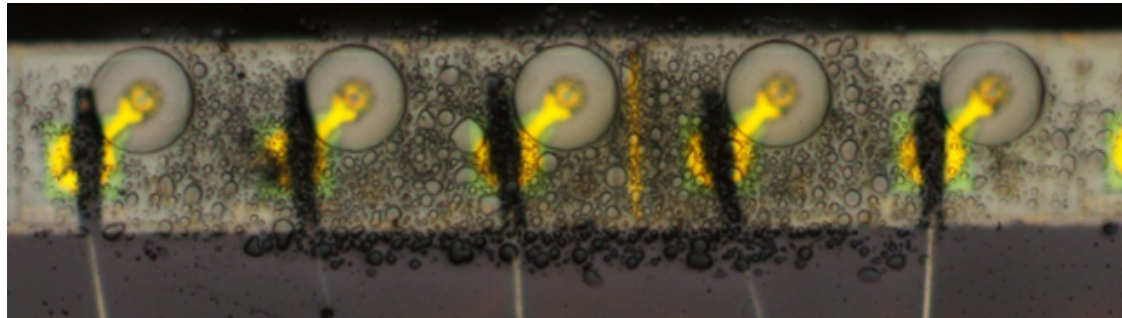
Failed OSU opto-pack

- Microscopic analysis shows 6 of the failed arrays have indentations in the optical epoxy
  - similar to those on several recently failed TX VCSELs
  - unfortunately no such indentations on other 8 failed arrays
