Lesson Learned from ATLAS Pixel Optical Link

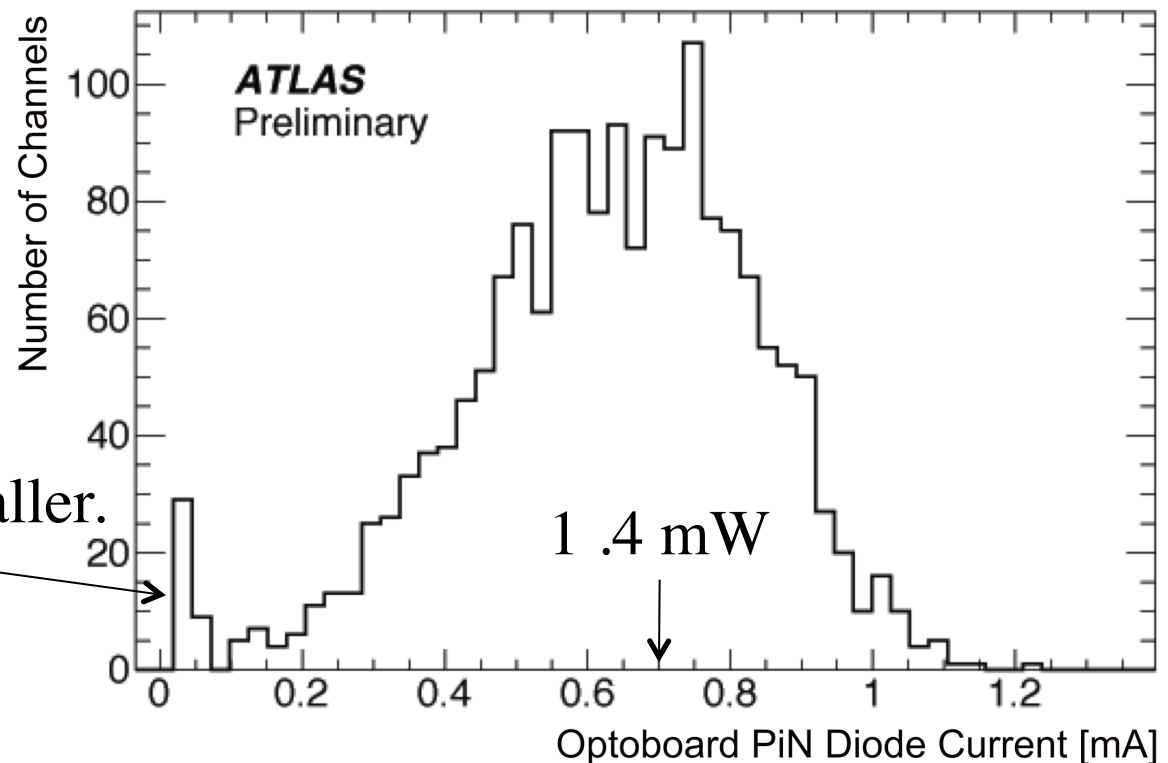
On-Detector PIN Current

- Monitoring of PIN current on opto-boards (on-detector) will tell us about the failures or radiation induced degradation

Actual failures much smaller.
See analysis later.

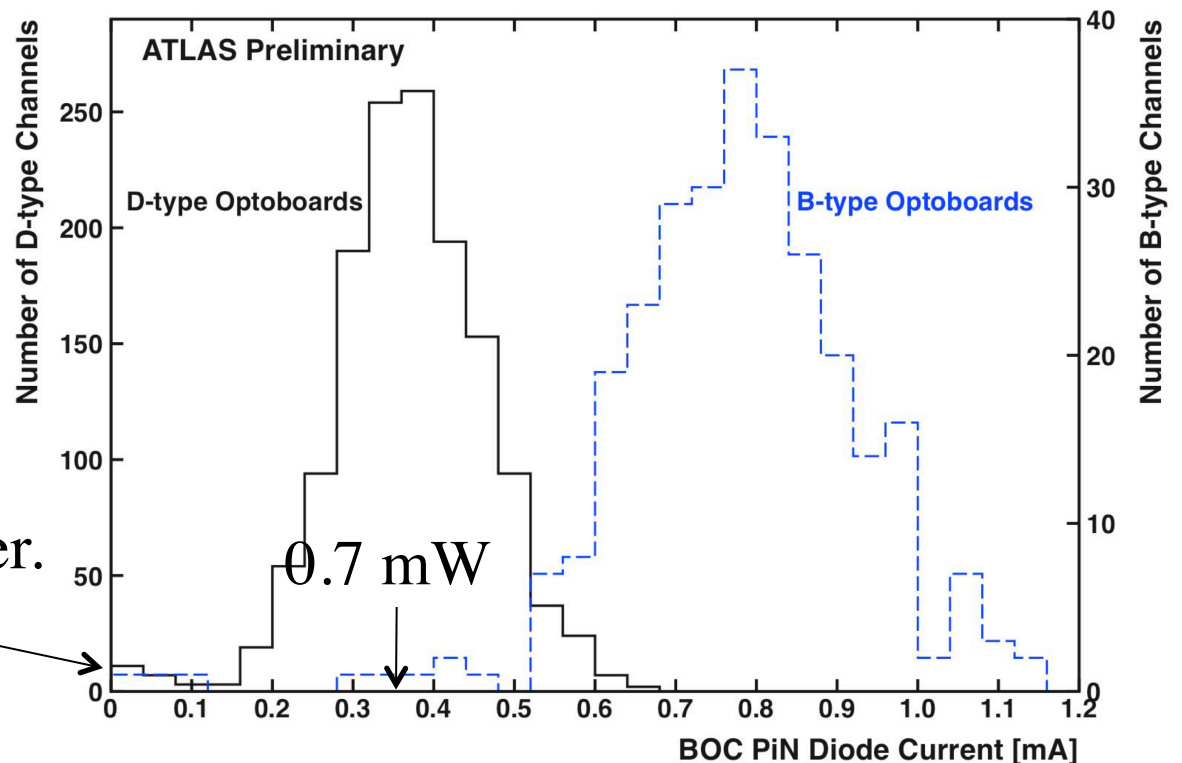
Off-Detector PIN Current

- Monitoring of PIN current on RXs (off-detector) will tell us about the failures or radiation induced degradation

Actual failures much smaller.
See analysis later.
