ULM 10 Gb/s VCSEL Array Accelerated Lifetime Study

K.K. Gan, H.P. Kagan, R.D. Kass, J. Moore, S. Smith
The Ohio State University

June 8, 2012

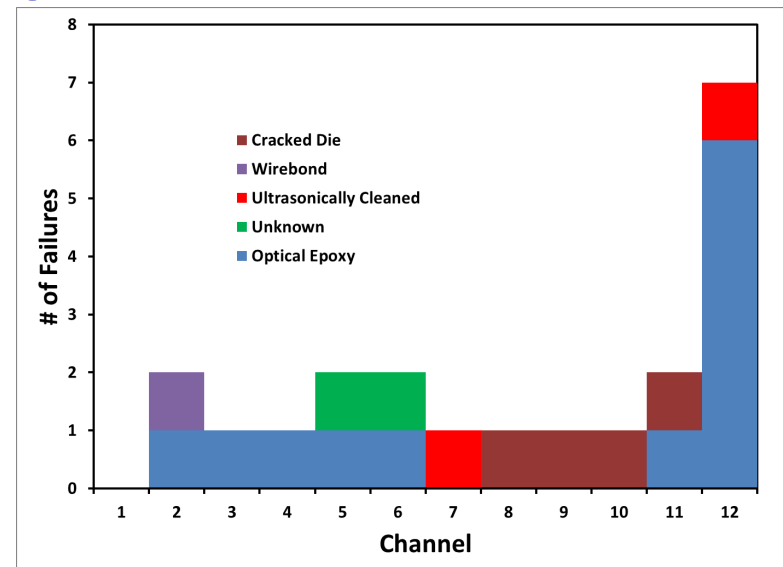
- 16 - optical epoxy coverage/scraping
 - ◆ including 4 on a cracked die
- 2 - no obvious/correlated cause
 - ◆ discolored die
- 2 - ultrasonic cleaning of die before placement
- 1 - broken wire bond during test

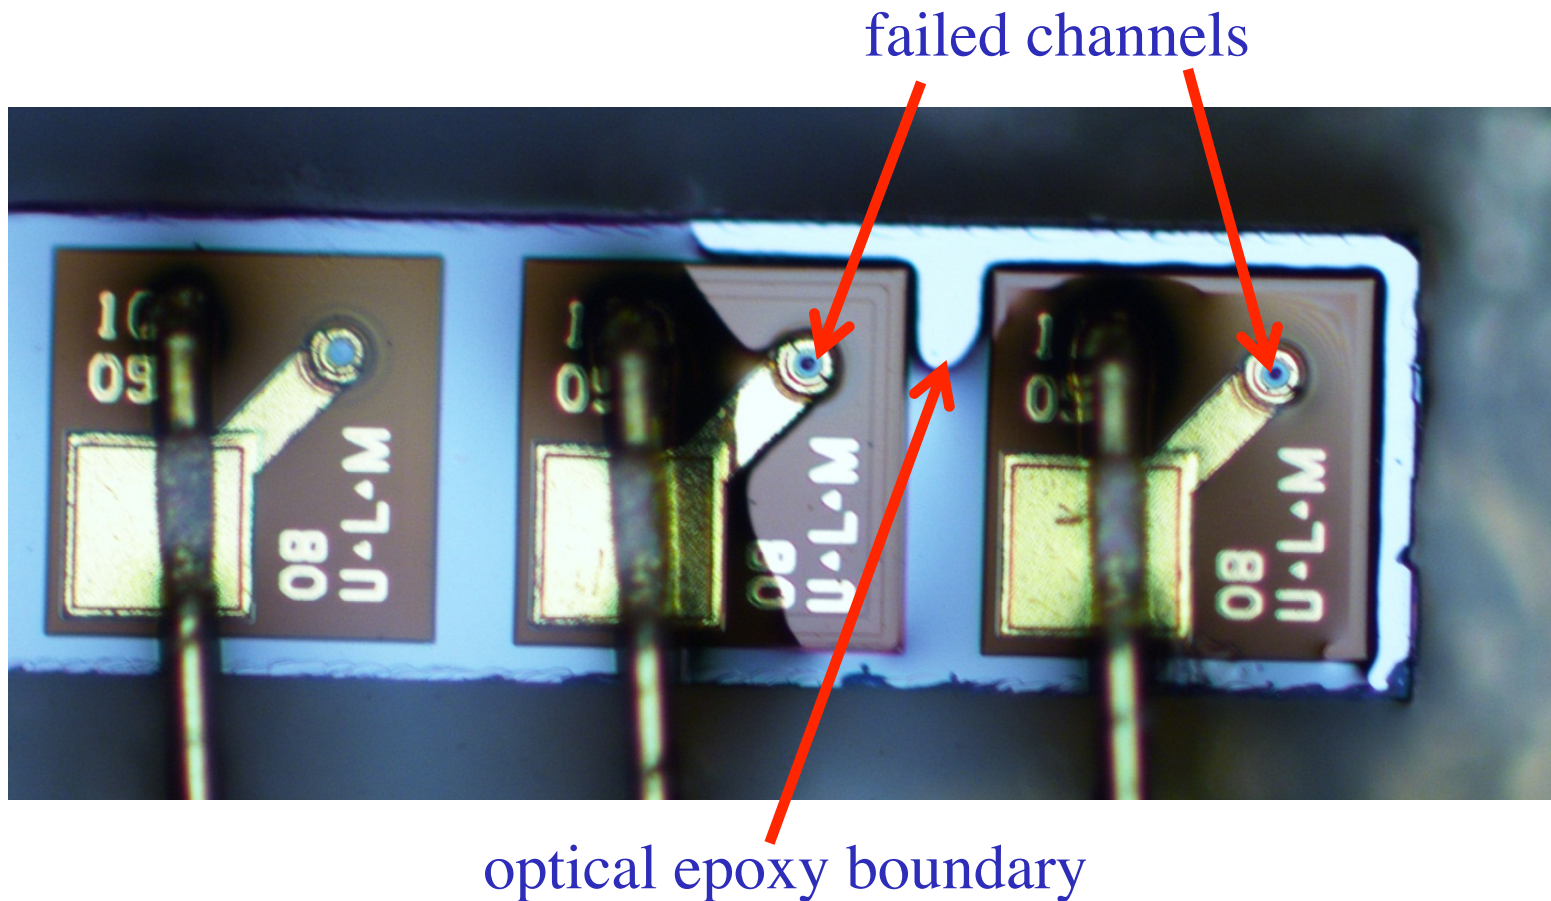
- All channels with incomplete epoxy coverage failed

- Add an optical epoxy dam
 - ◆ keeps epoxy from climbing the MT guide pins
 - ⇒ no optical epoxy scraping
 - ◆ adds reservoir to assist in complete epoxy coverage
 - ◆ doubles as MT ferrule bumper
- Presently constructing 20 Finisar arrays with the optical epoxy dam for next lifetime test
 - ◆ dam successfully tested on two arrays

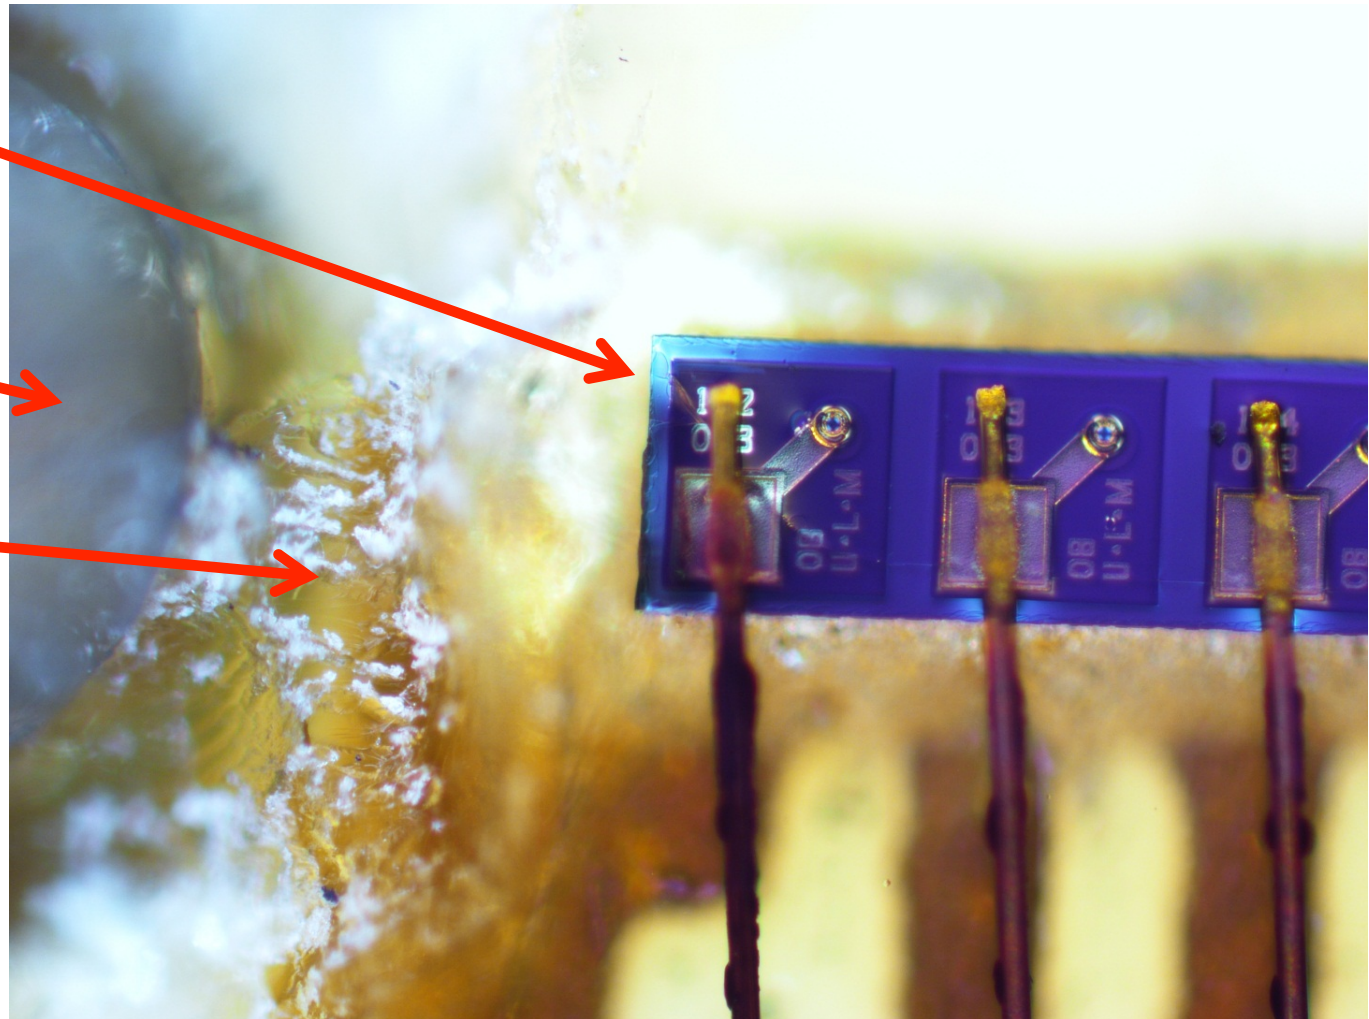
Cracked Die

- not possible to have complete epoxy coverage without epoxy around MT guide pins
 - ⇒ epoxy wick up the guide pins due to capillary effect
 - ⇒ scrape epoxy from guide pins to allow proper fiber coupling
 - ⇒ the accelerated lifetime study reveals that this might cause long term reliability issues:
 - ◆ cracked a die (which survived nearly the whole test)
 - ◆ introduced stress in a few arrays

Crack in die
(continues to
channel 8)

Scraped
optical epoxy

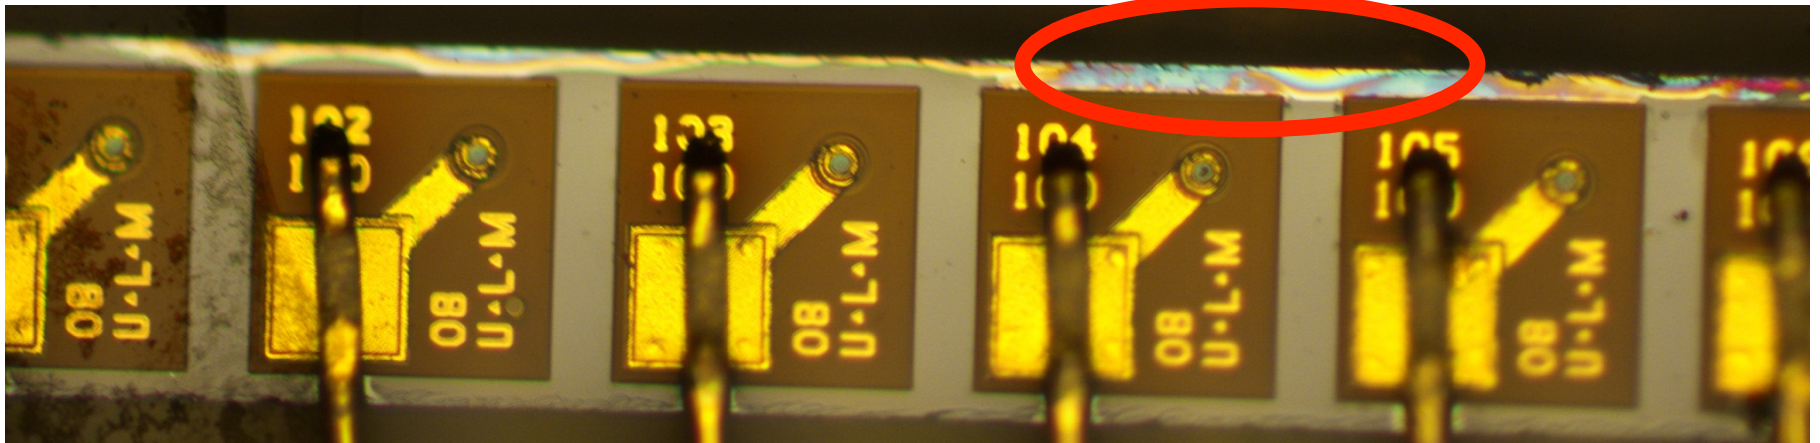
- Discoloration on the die with a failed channel

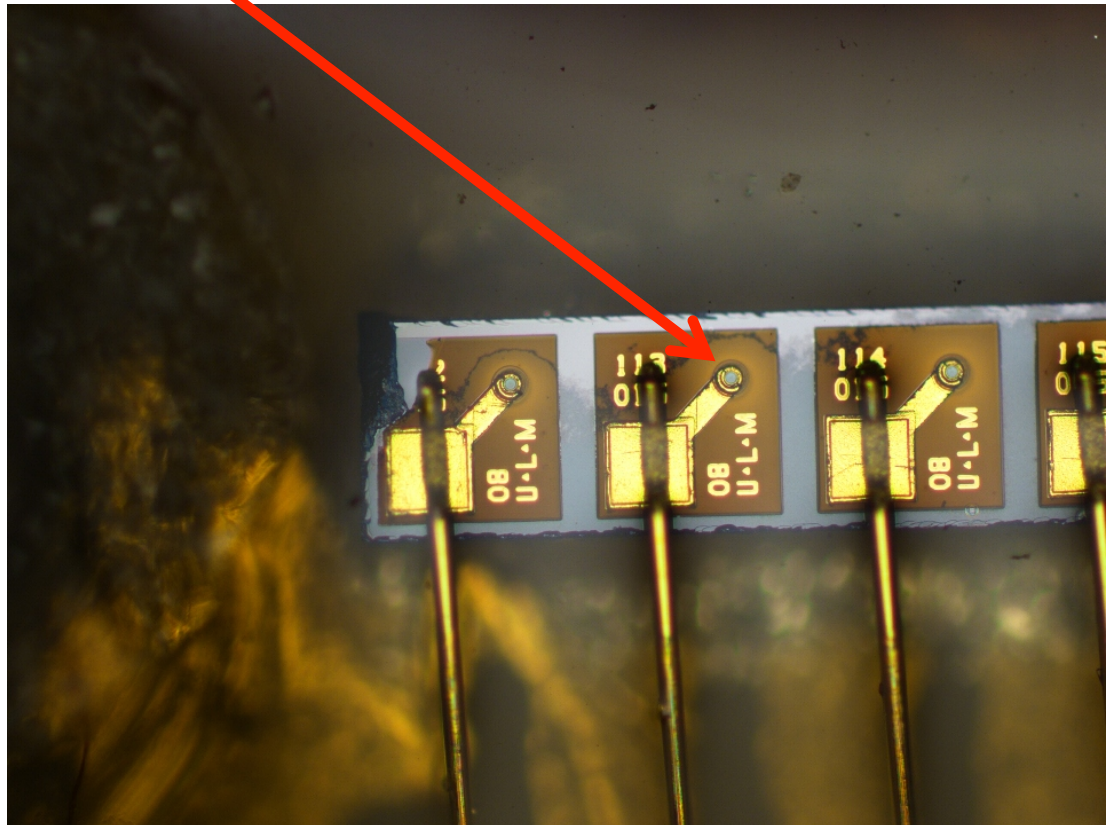
- This die has discoloration but it passed the 85/85 test
 - ◆ ring around the MESA
 - ◆ problem with polyimide on channel 1

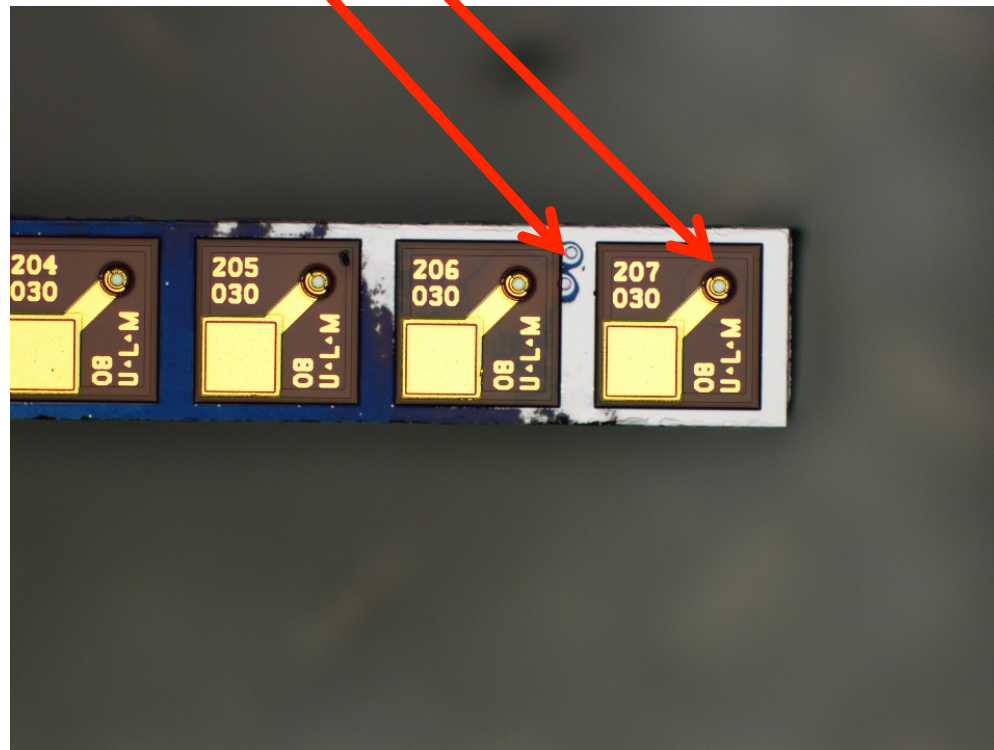
- Rings around MESA
 - ◆ ULM says they are normal
- strange bubble structures
 - ◆ present on many dice
