# Results of VCSEL Failure Investigations and Qualifications

B. Cote, K.K. Gan, H. Kagan, Z. Pollock, S. Smith, C. Tandoi, B. Tar, A. Woyshville  
The Ohio State University

June 3, 2019

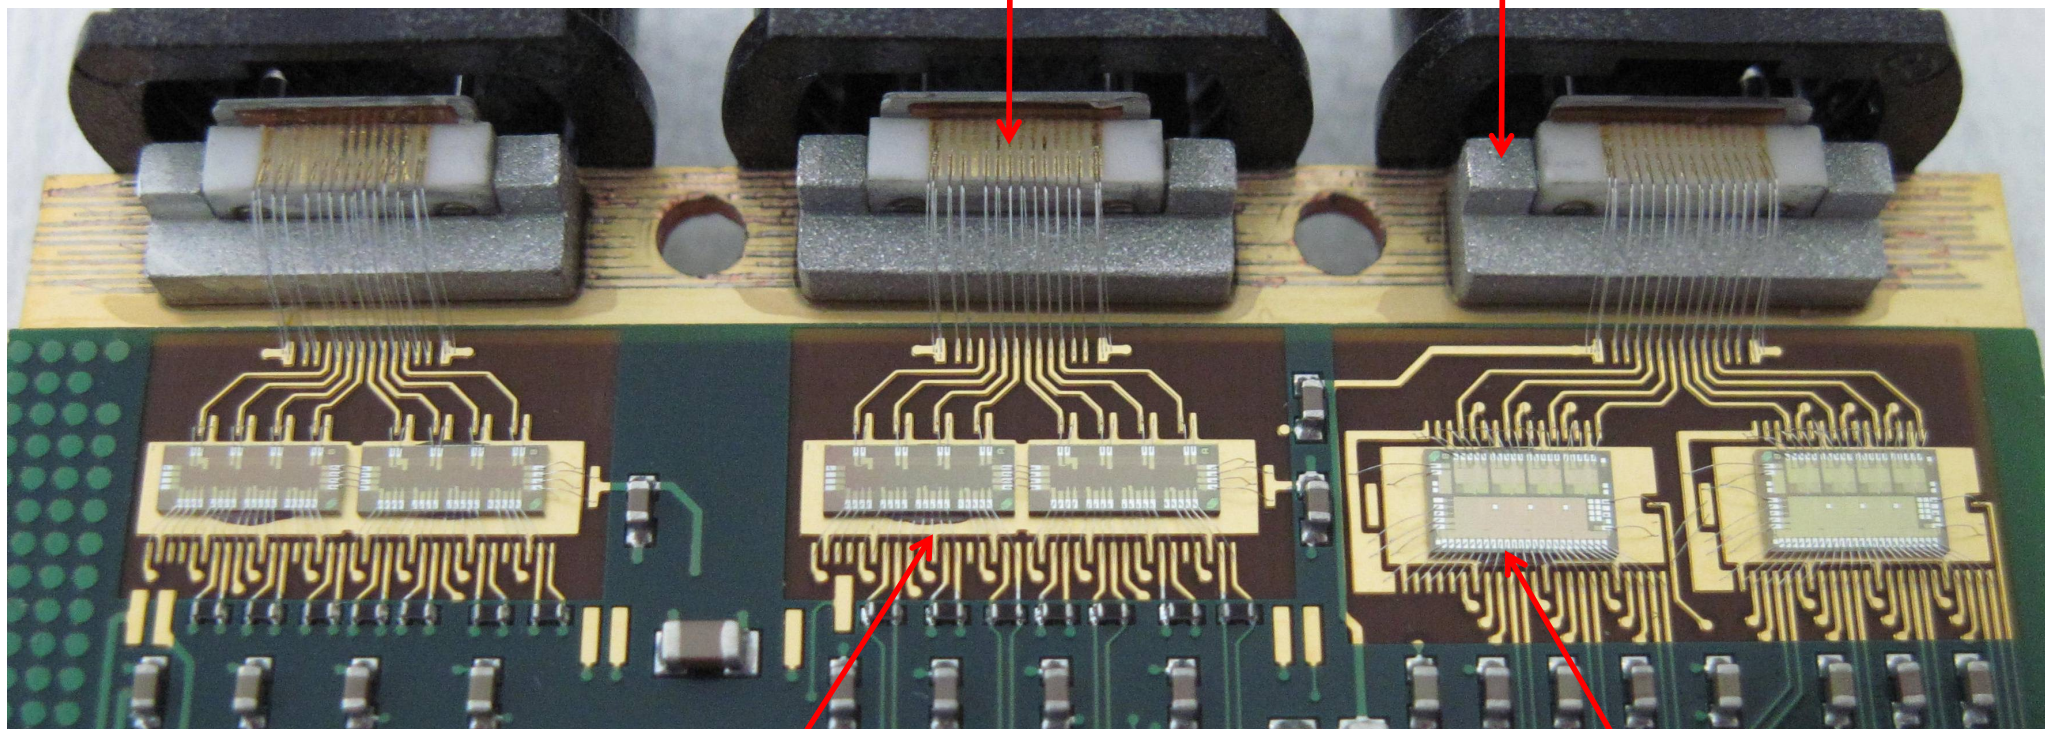
Opto-pack

Aluminum brace

VDC  
(VCSEL driver)

DORIC  
(PIN receiver/decoder)

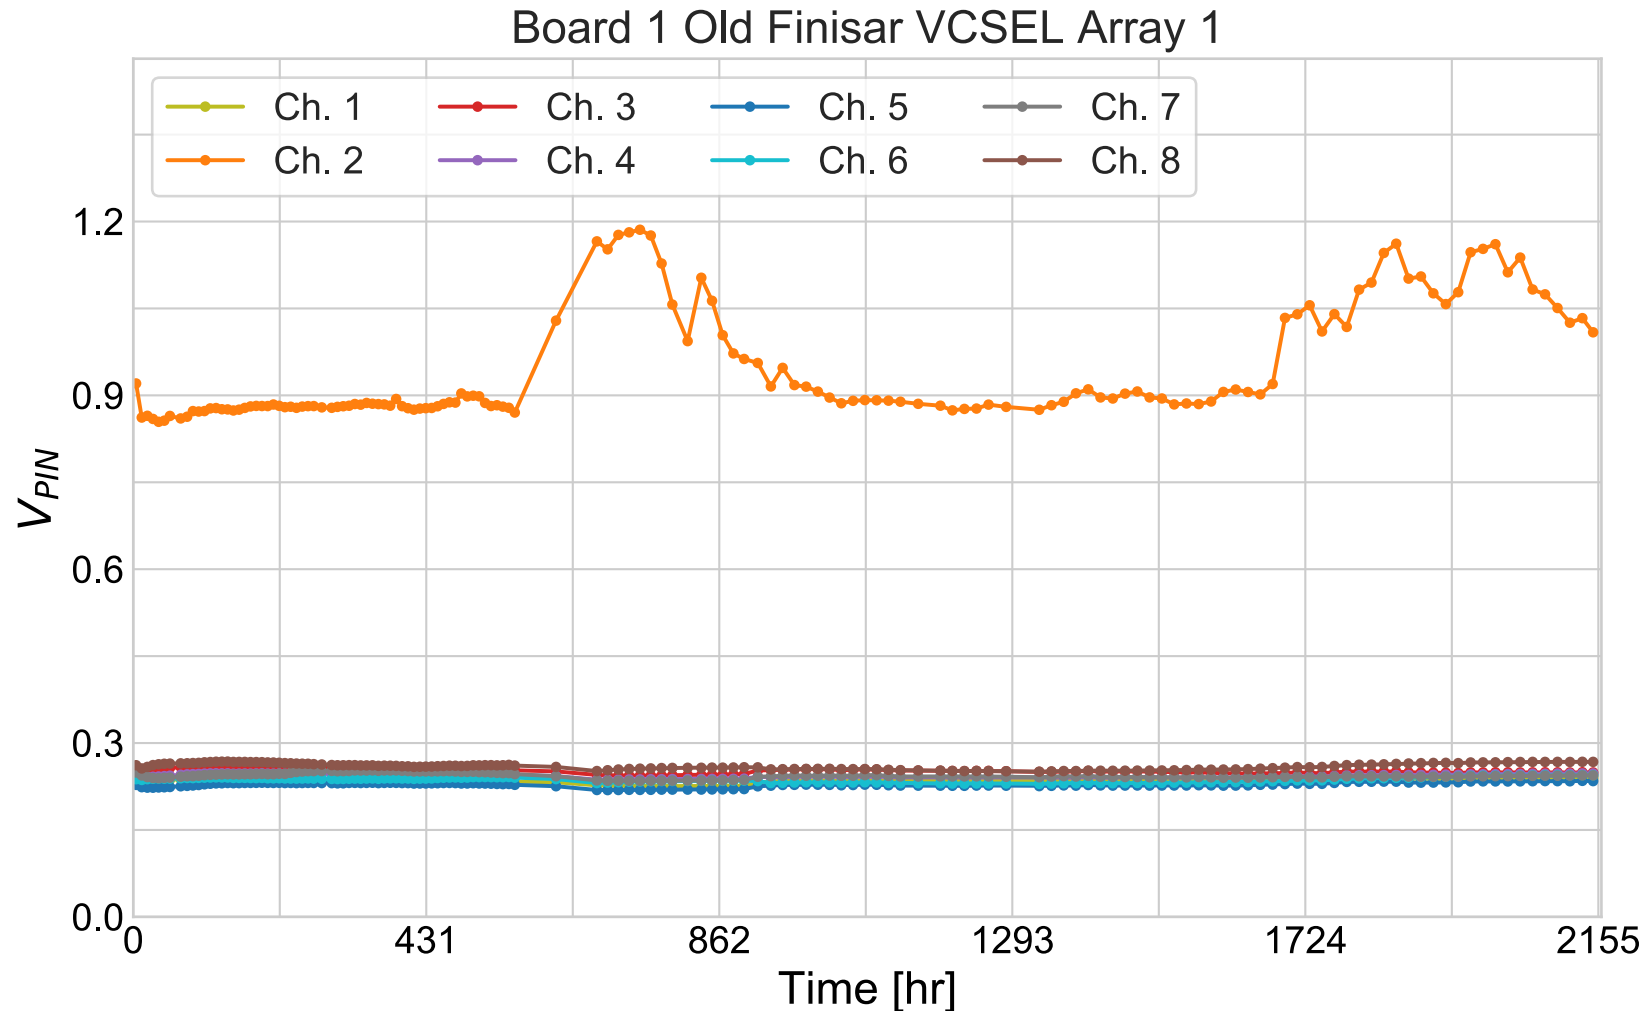
- 1 out 112 channels has connection problem: receiving all “1”
- VCSEL not dead!!

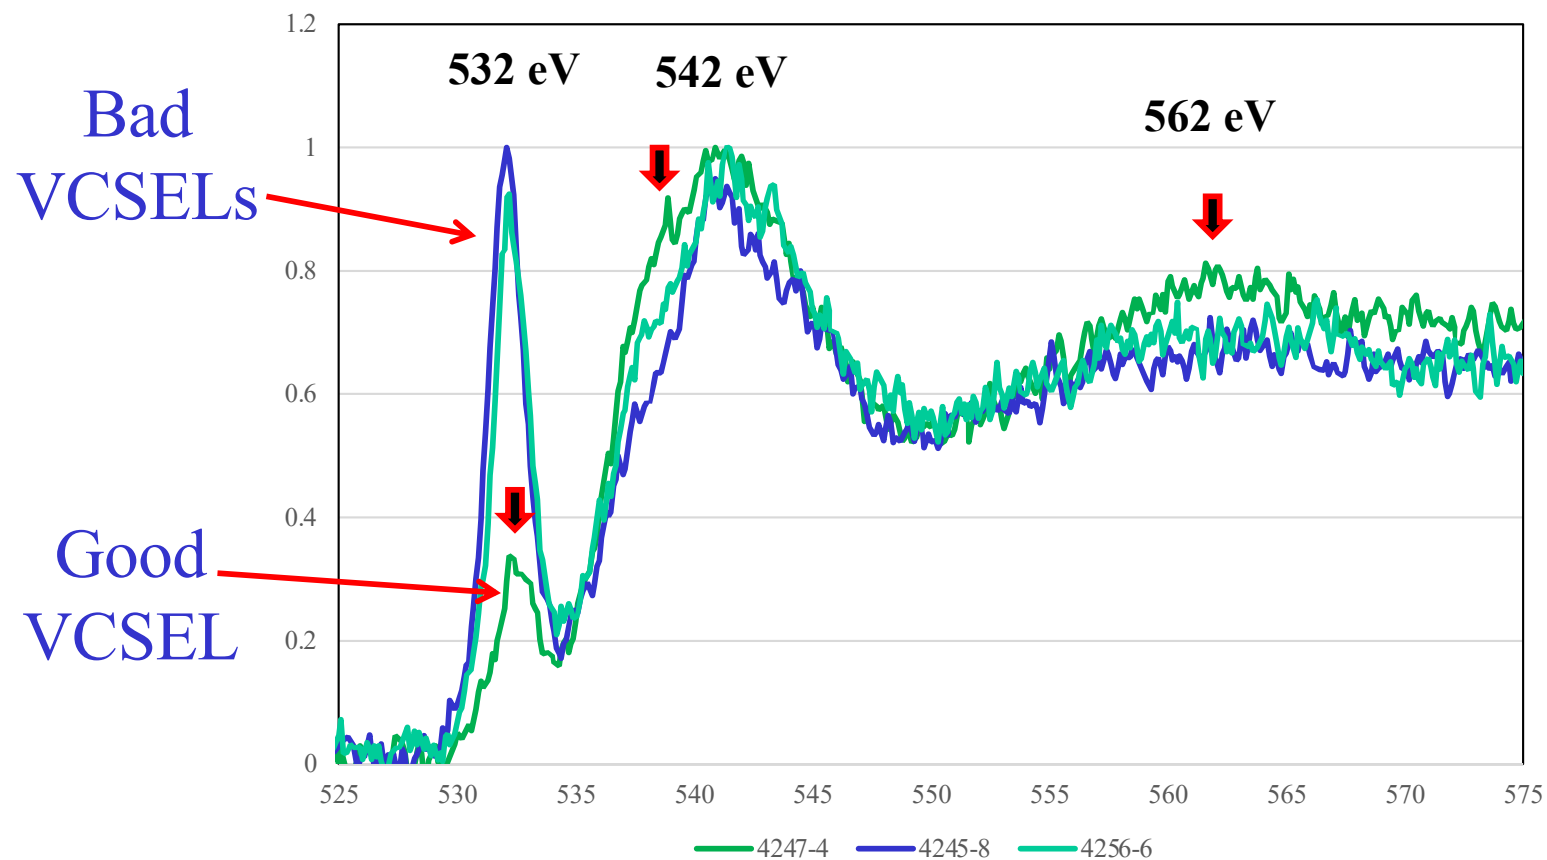
Here is the data work up from the experiment we recently performed. The EELS shows that there is a significant difference between the Failed VCSELs and the Good Reference VCSEL with regards to the Oxygen K edge fine structure. The failed VCSELs show a large increase in the 532eV pre peak as compared to the Good VCSEL control. If you have time this afternoon...

While we have found evidence in the literature for this pre-peak to be associated with dehydration of Al hydroxide, we are still unsure of its true source as there are also references that show this more associated with molecular Oxygen, O<sub>2</sub>. My hypothesis was that there might be excess water uptake in the bad VCSELs, and using the reference I found this would seem to support that theory, but I am not comfortable making that conclusion just yet. More work needs to be done to understand the origin of this oxide chemistry difference and whether this correlation of the 532 eV peak with failed VCSELs can be repeated.

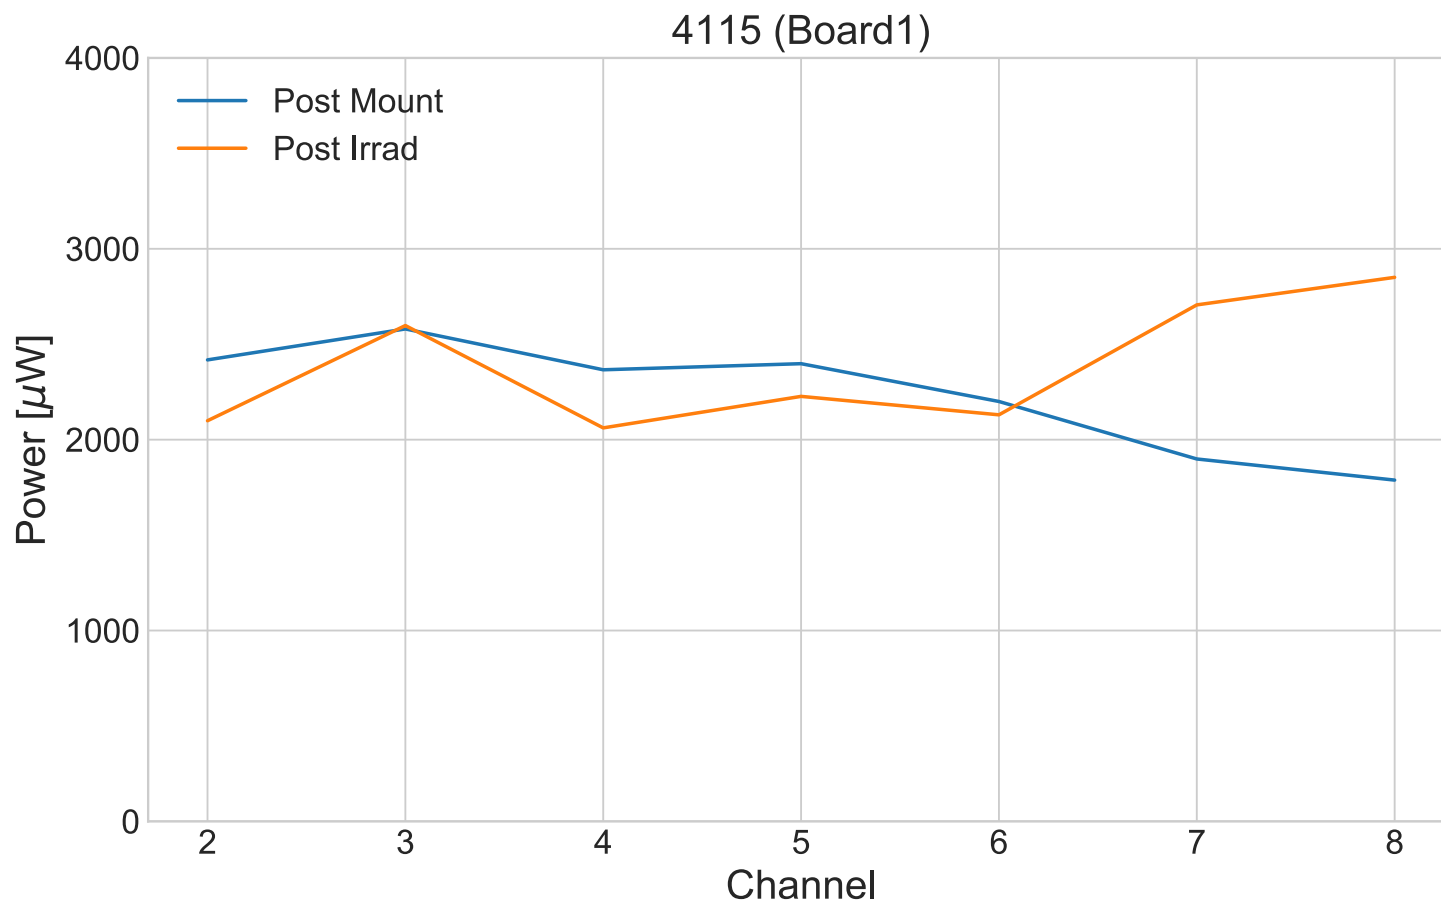
- Finisar: all channels are still operational with good optical power

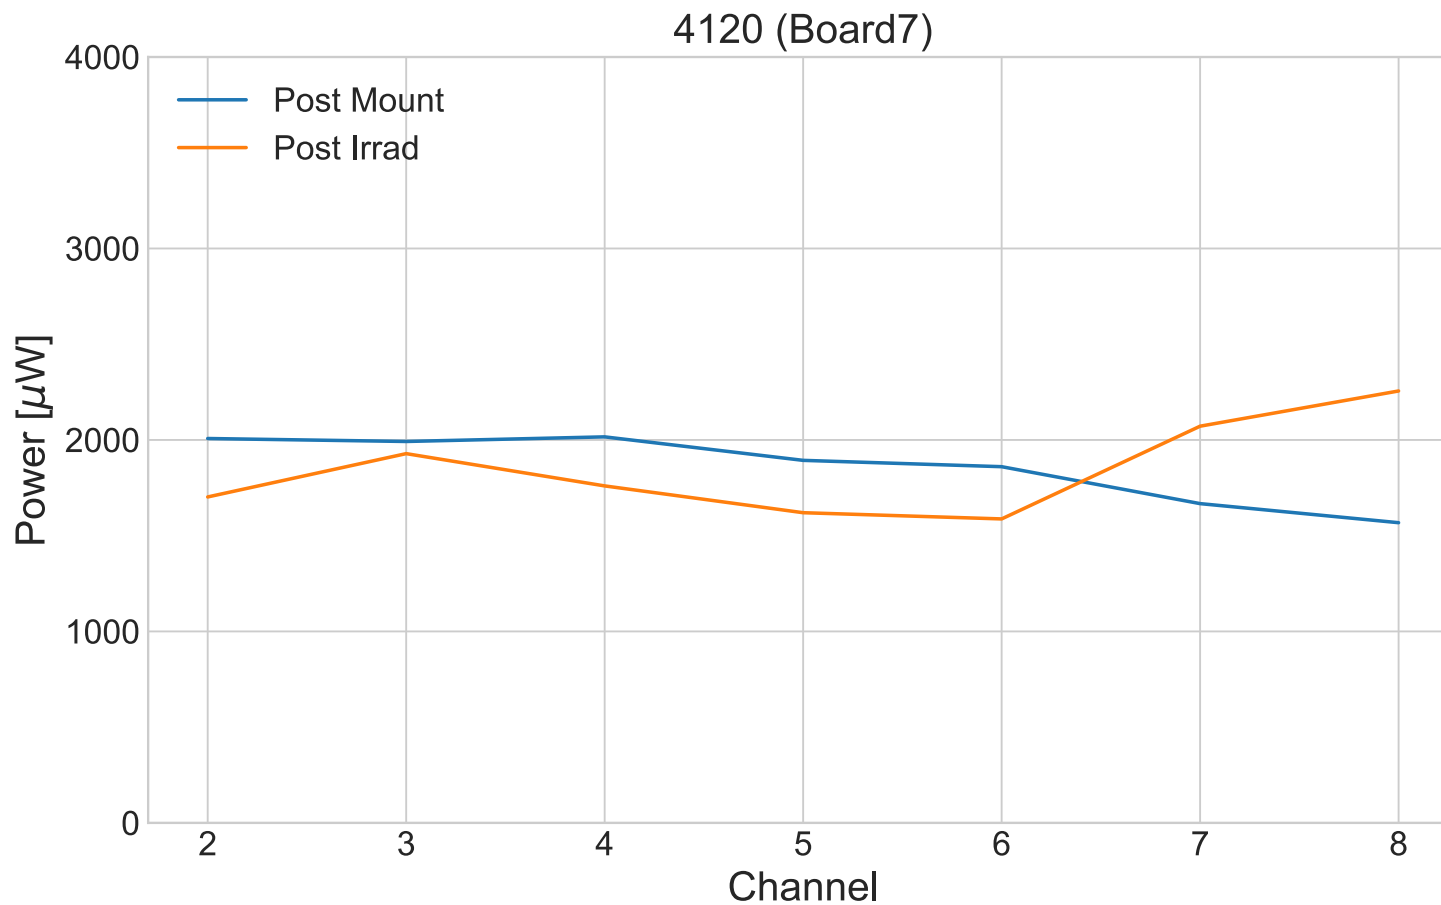
- ULM: all channels are still operational with good optical power

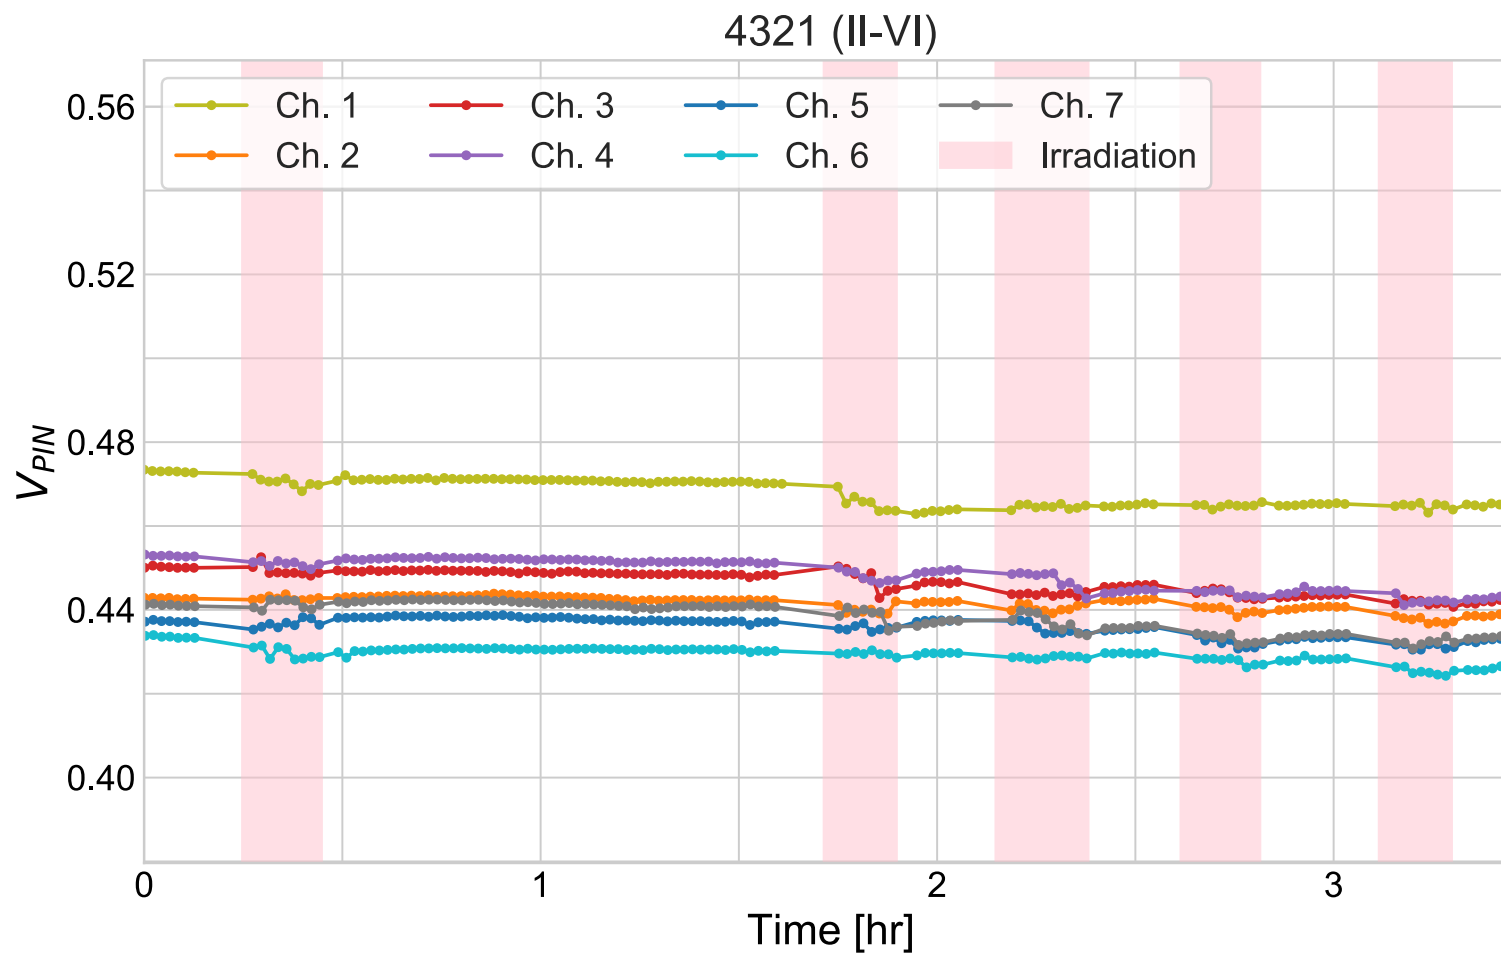
- II-VI: no VCSELs died during irradiation

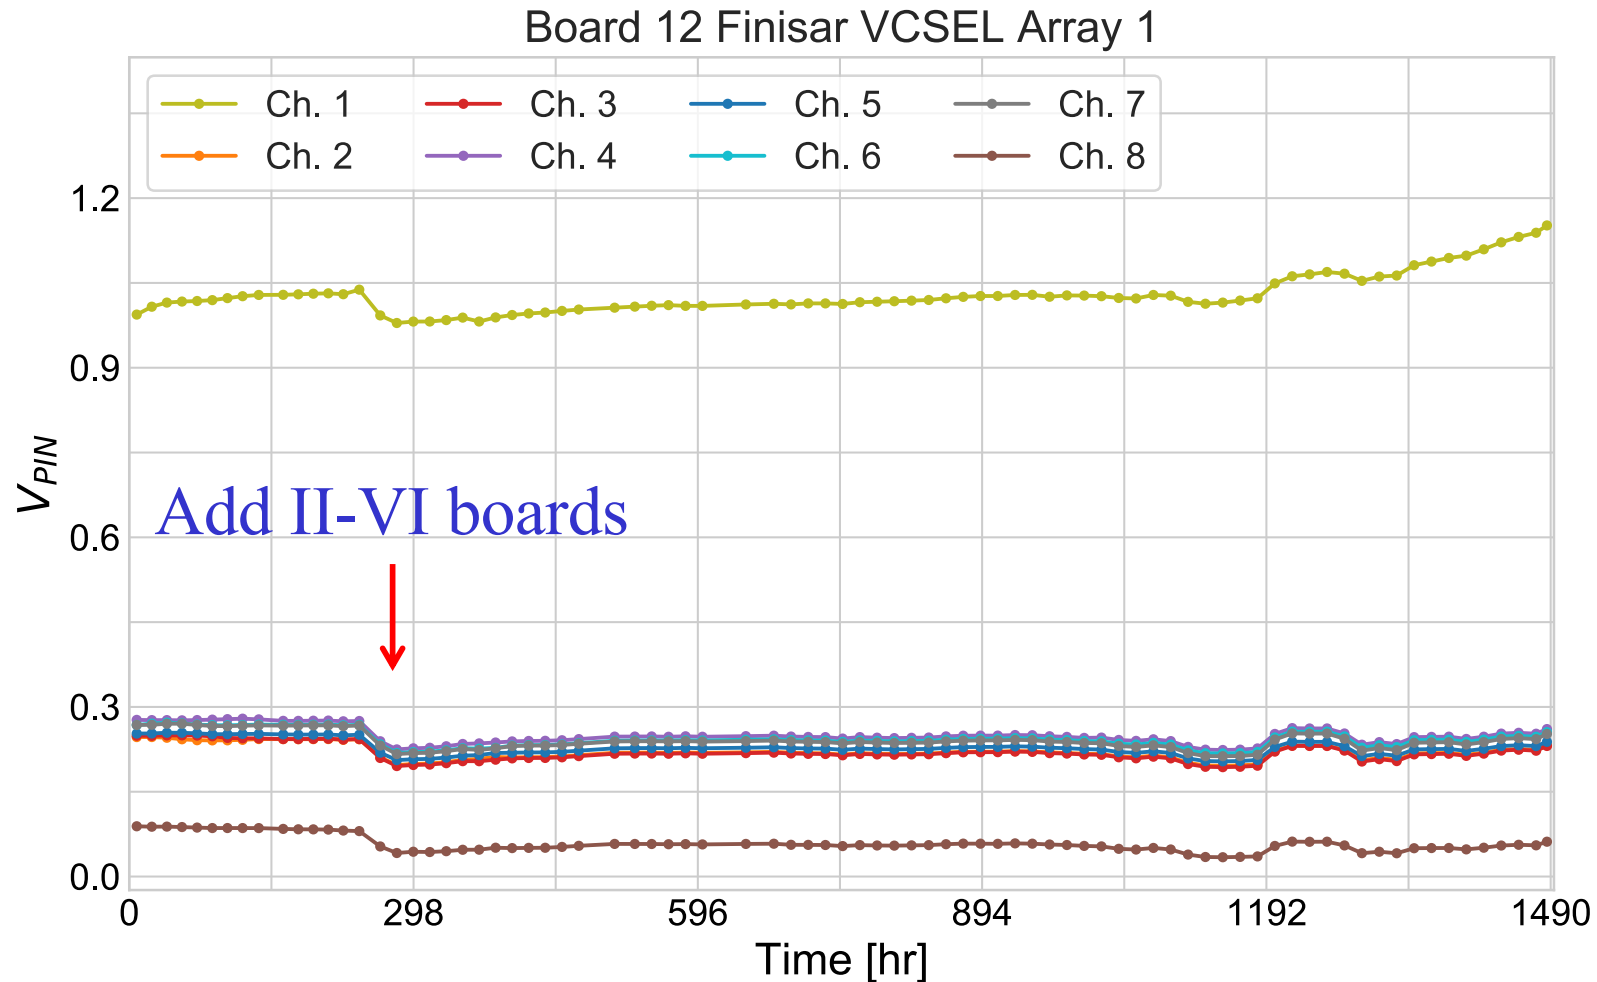
- Finisar: channel #1 has connection problem: receiving all “1”
- VCSEL not dead!!

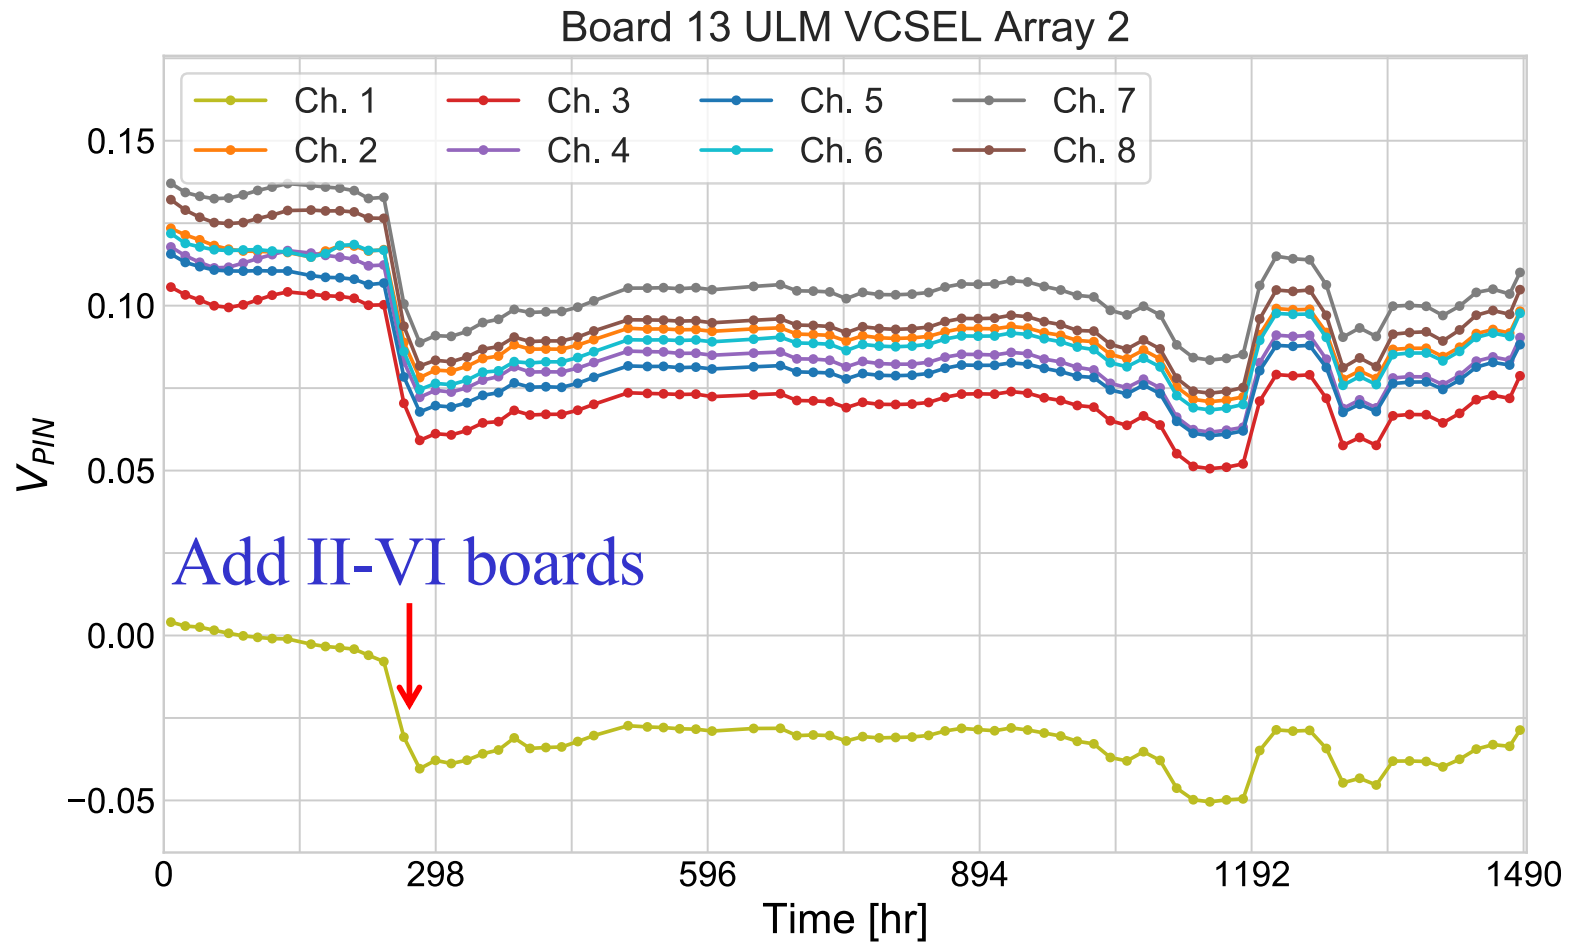
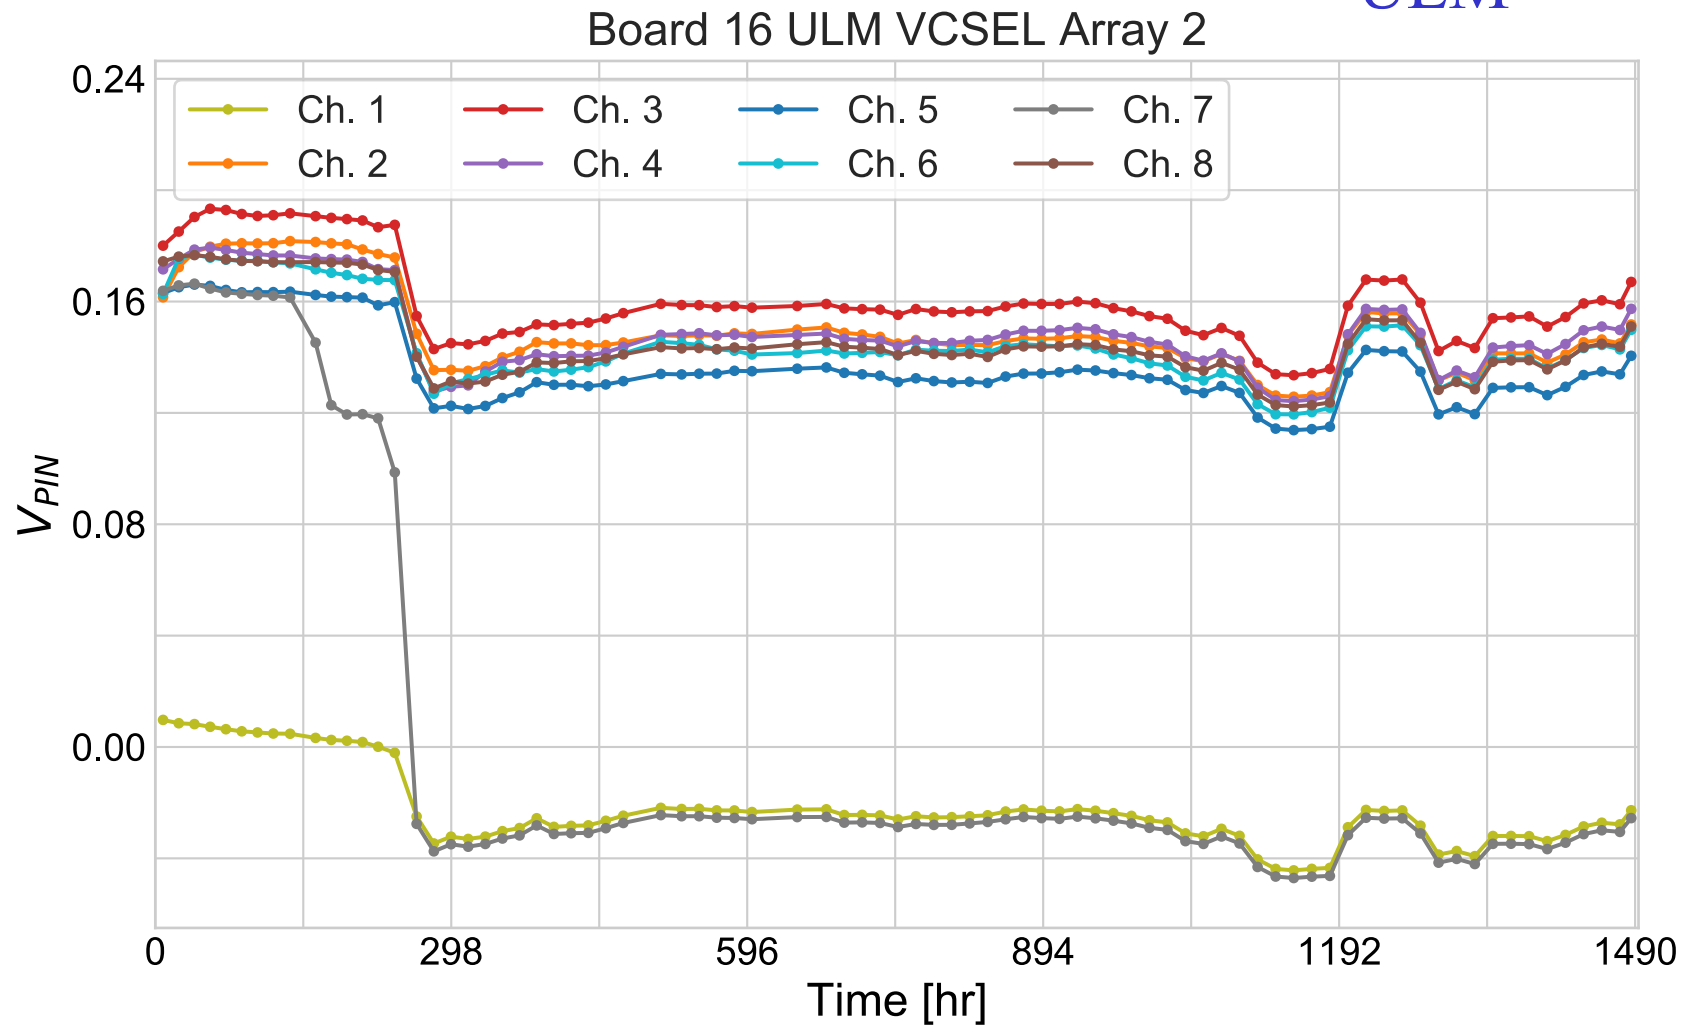
ULM

- power of one channel started to decrease after ~140 hours at 85 C/85% RH
  - died at ~250 hour
- no additional fatality in other 55 channels in next 1200 hours
- Is this infant fatality?
- Can check for ESD after removal of opto-pack at 2000 hour
