Status of Preparation for Opto-Board Replacement

B. Cote, K.K. Gan, H. Kagan, Z. Pollock, S. Smith, S. Monnin, B. Tar, A. Woyshville The Ohio State University

> > Nov 11, 2020

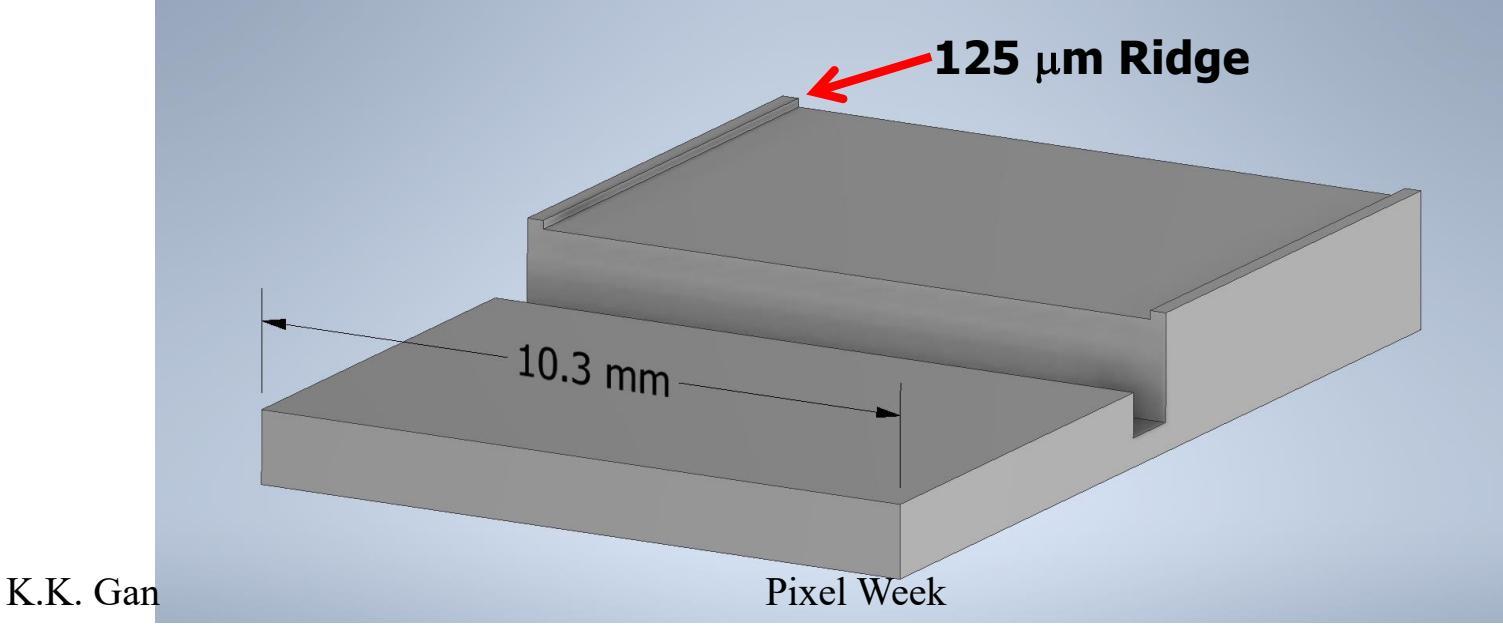
Opto-Connector Improvement

- several opto-connectors detached from opto-boards during the 2013/14 installation of opto-boards
 - bond between smooth aluminum and copper surfaces is not strong
 - ➡ both surfaces are now scored
 - aluminum connector modified to guarantee that epoxy cannot be completely squeezed out

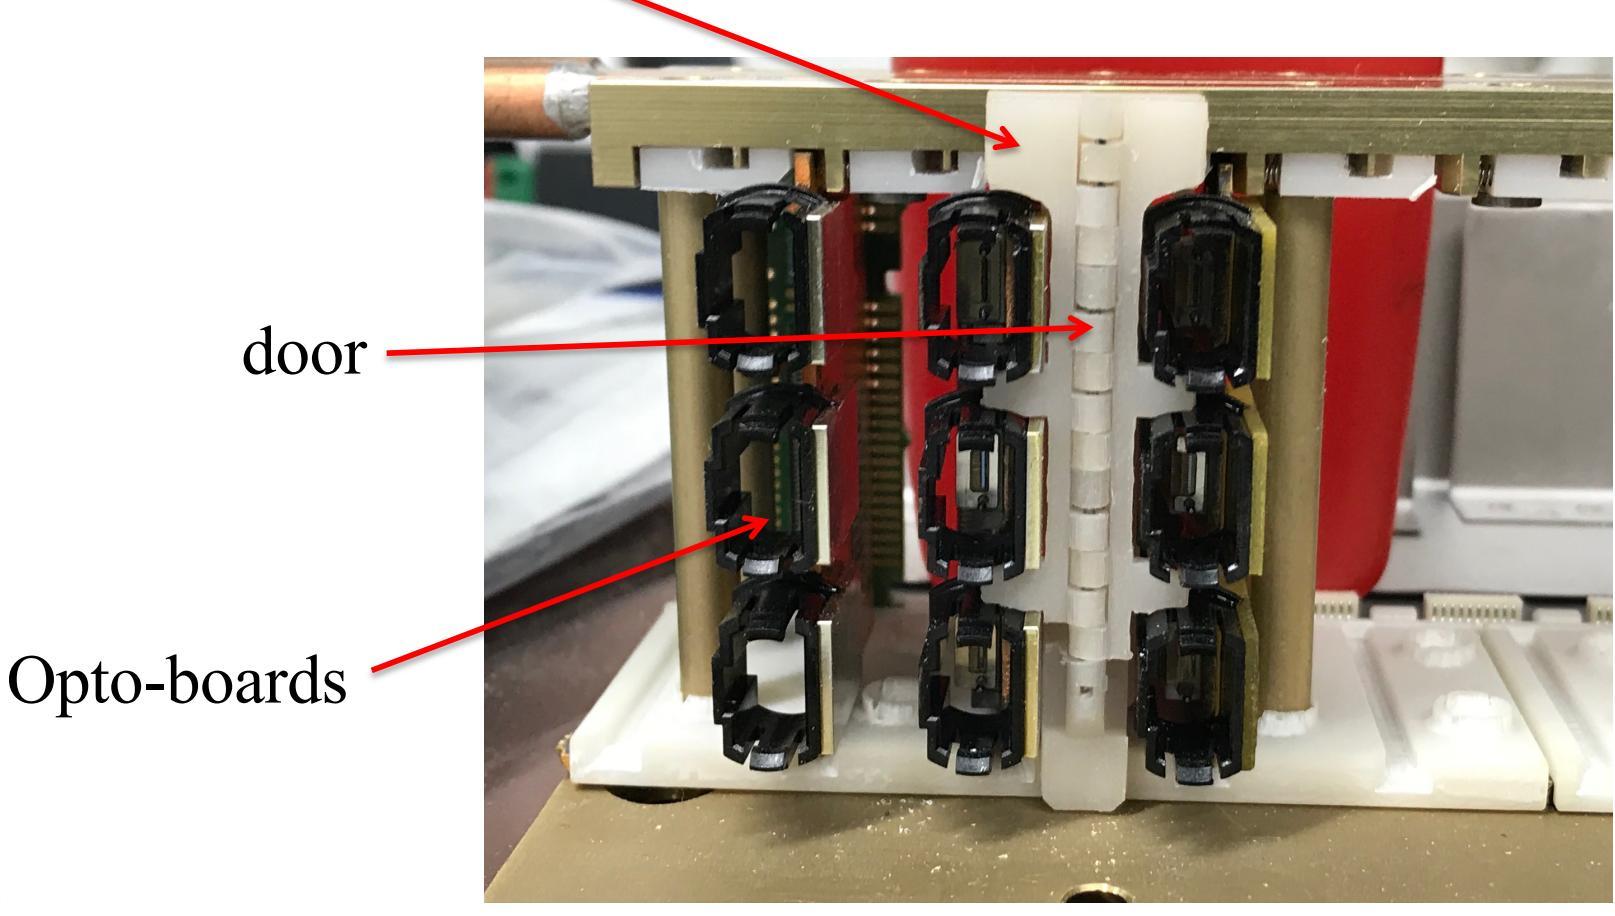
Opto-Box Sealing

- opto-boxes were supposed to be flushed with dry air
 - box is not air tight due to cables/fibers
 - ➡ improve sealing

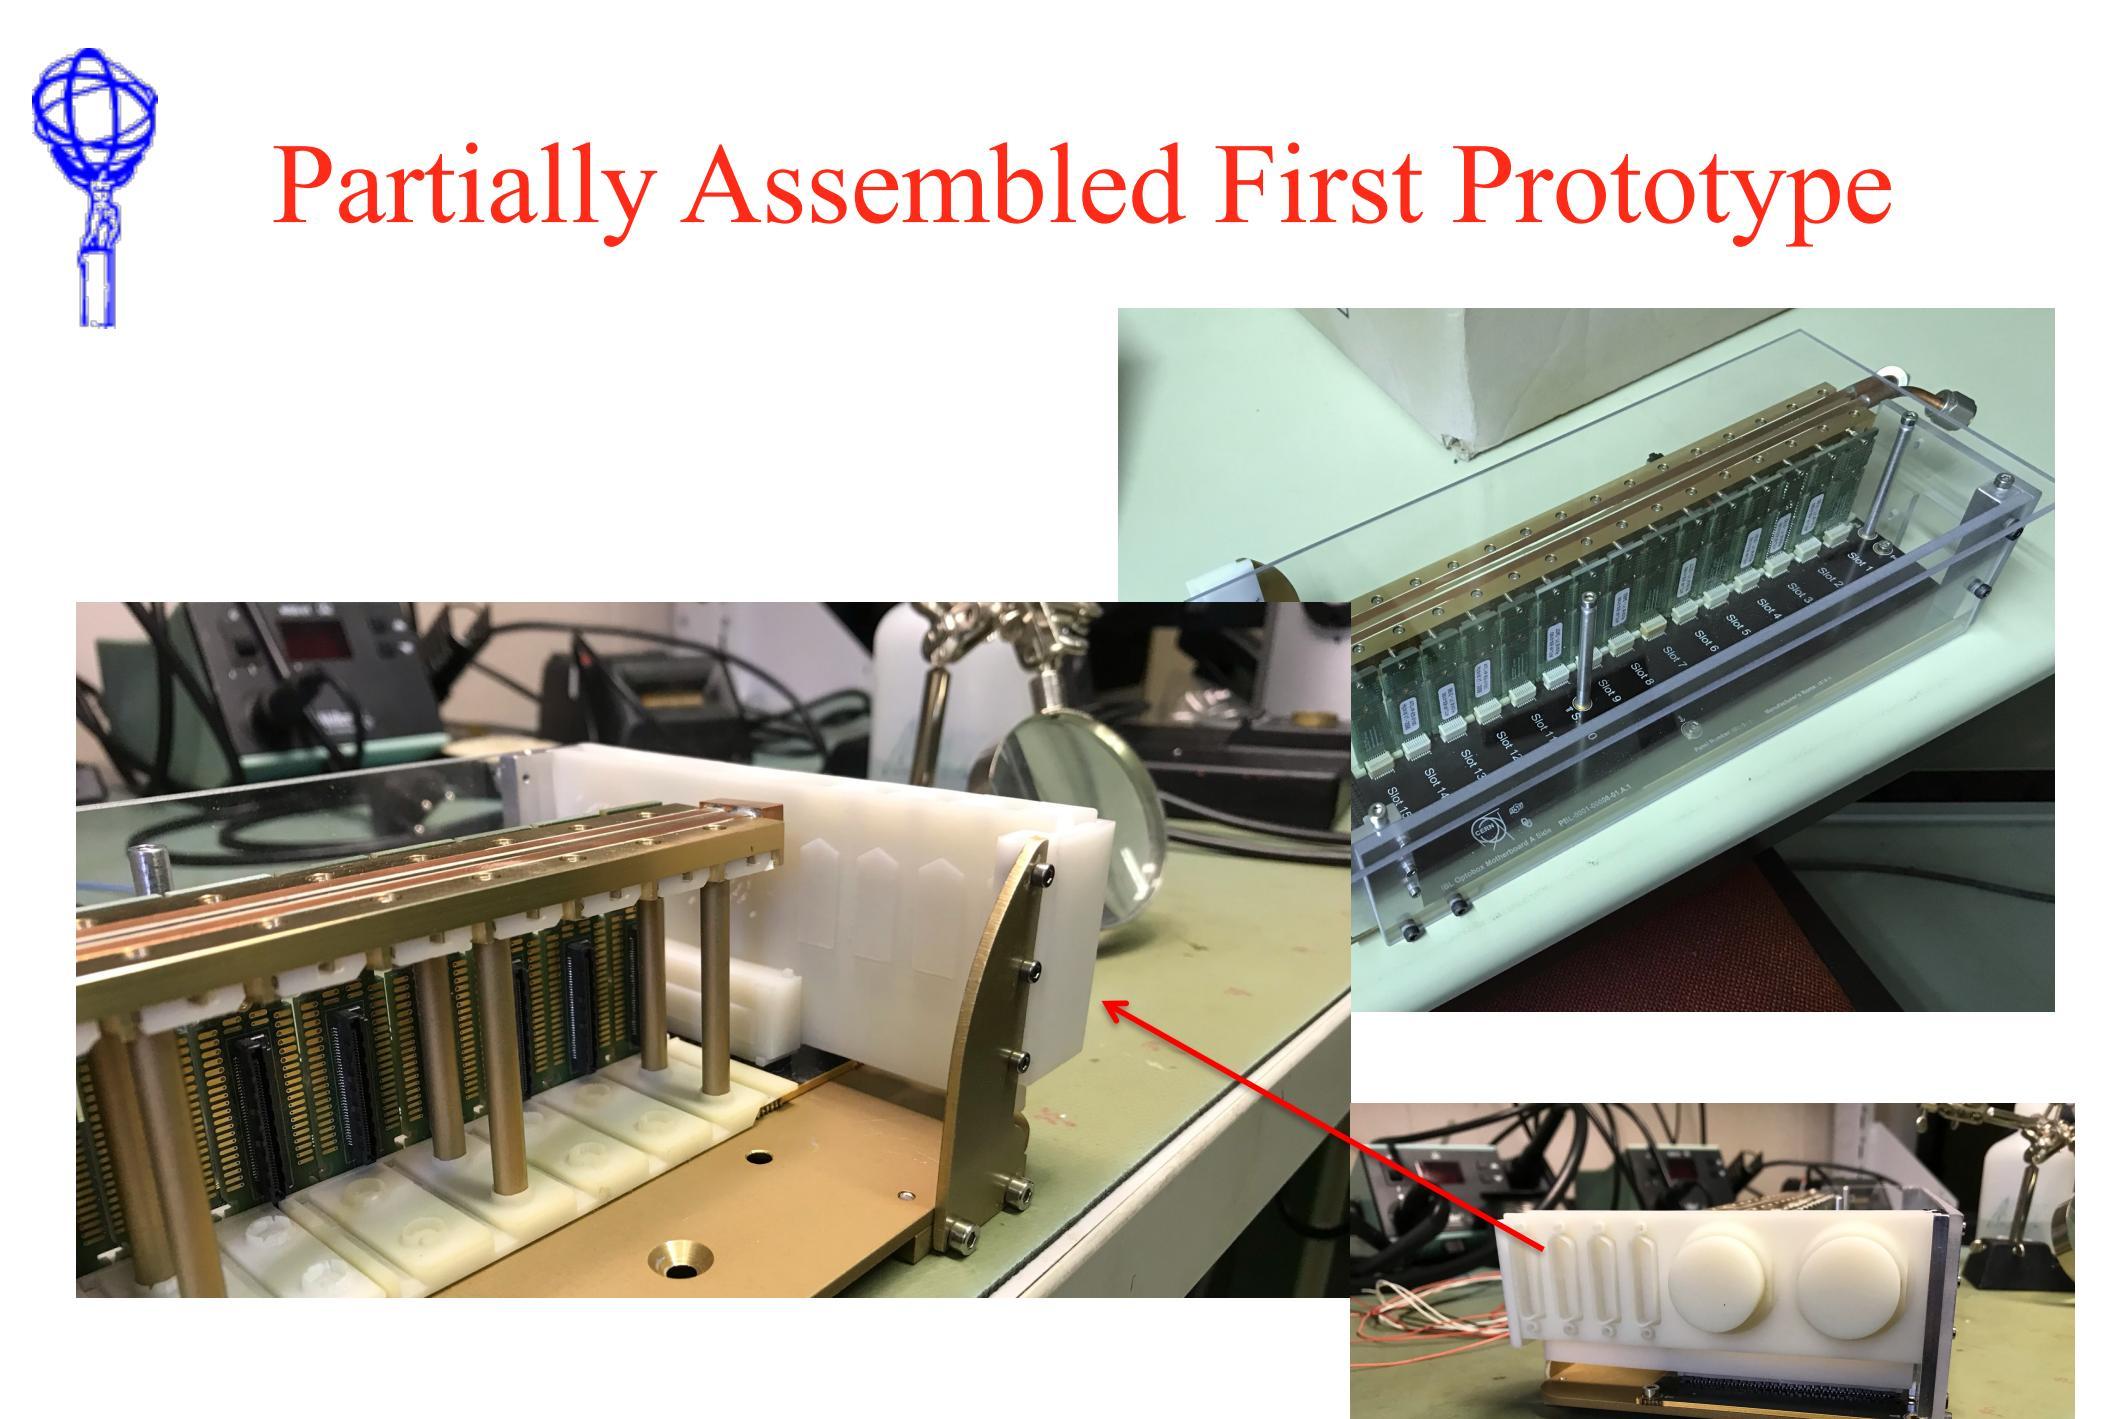
Prototype Status

- parts have been received and test fit
 - 3D printed box end board is working well
 - 2nd round of 3D printed doors don't fit that well
 - probably due to a change in the orientation of the print
 - ◆ acceptable tolerances have been specified
 ⇒ should fix the issue.
 - 3rd round is scheduled to be finished on November 10th
- climate chamber has been serviced and is being characterized
- once the new parts are fitted
 - characterize the sealing performance of the opto-box in terms of humidity vs. flow rate of dry air
