# Status of On-Detector Opto-Links

K.K. Gan, H. Kagan, R.D. Kass,  
J. Moore, D. Pignotti, S. Smith  
The Ohio State University

October 12, 2012

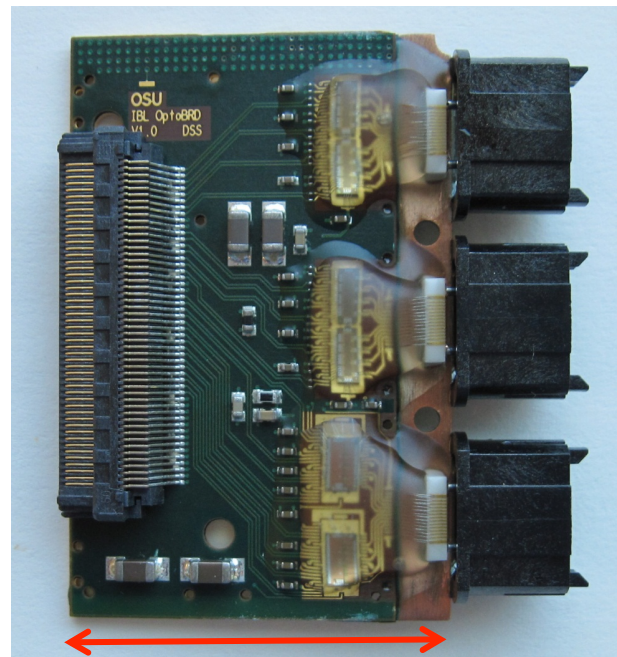
- One IBL opto-board fabricated
  - ◆ pass go/no go
  - ◆ pass QA after burn-in and thermal cycle
- Building 9 more for system test distribution

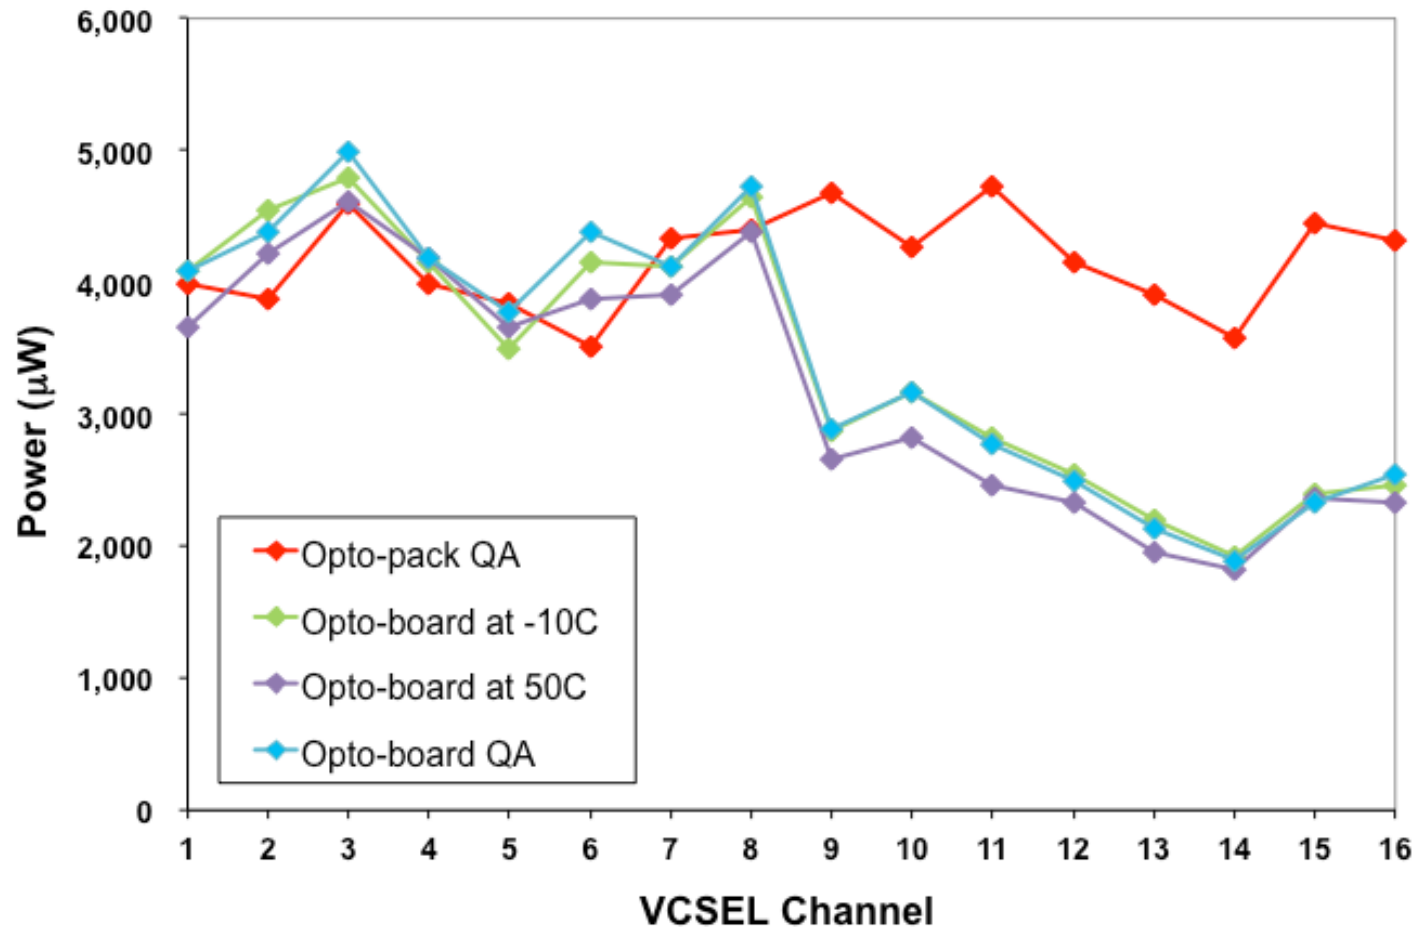
● Excellent optical power!!!

Need optical  
connector  
mounting jig

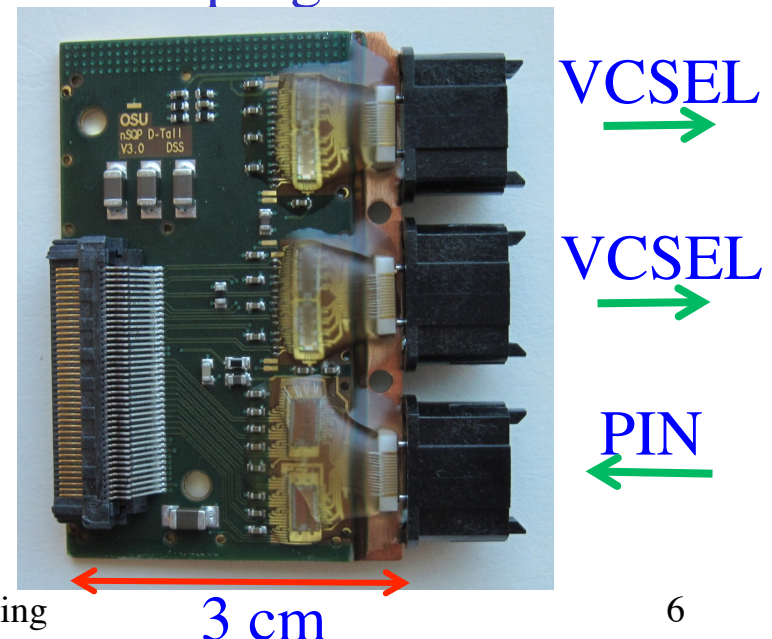
- four nSQP B opto-boards distributed: CERN, SLAC, Wuppertal, Bern
- One nSQP D opto-board fabricated
  - ◆ pass go/no go
  - ◆ wirebond failures after thermal cycling on DTO2 VDC to opto-pack
    - ⇒ optimization of wire bond parameters in progress

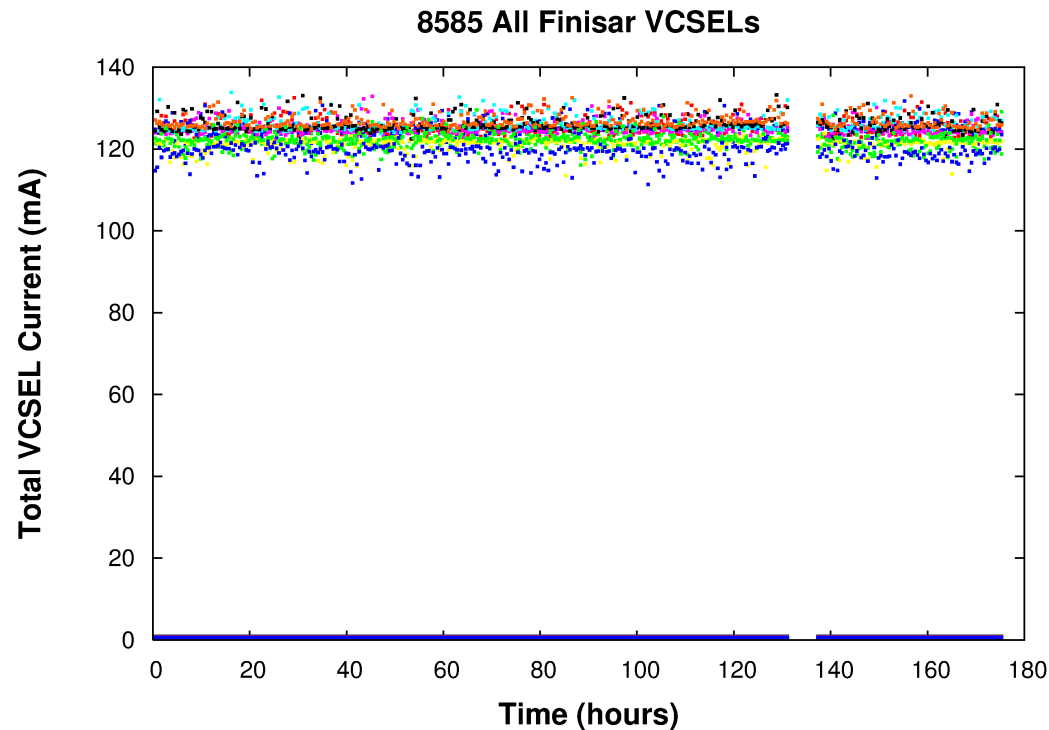
- switch from aluminum to gold wire bonds
- no optical epoxy
- began test on 10 arrays
  - no failures after 175 hours
