Status of Preparation for Opto-Board Replacement

B. Cote, K.K. Gan, H. Kagan, Z. Pollock, S. Smith, S. Monnin, B. Tar, A. Woyshville The Ohio State University

> > Nov 11, 2020

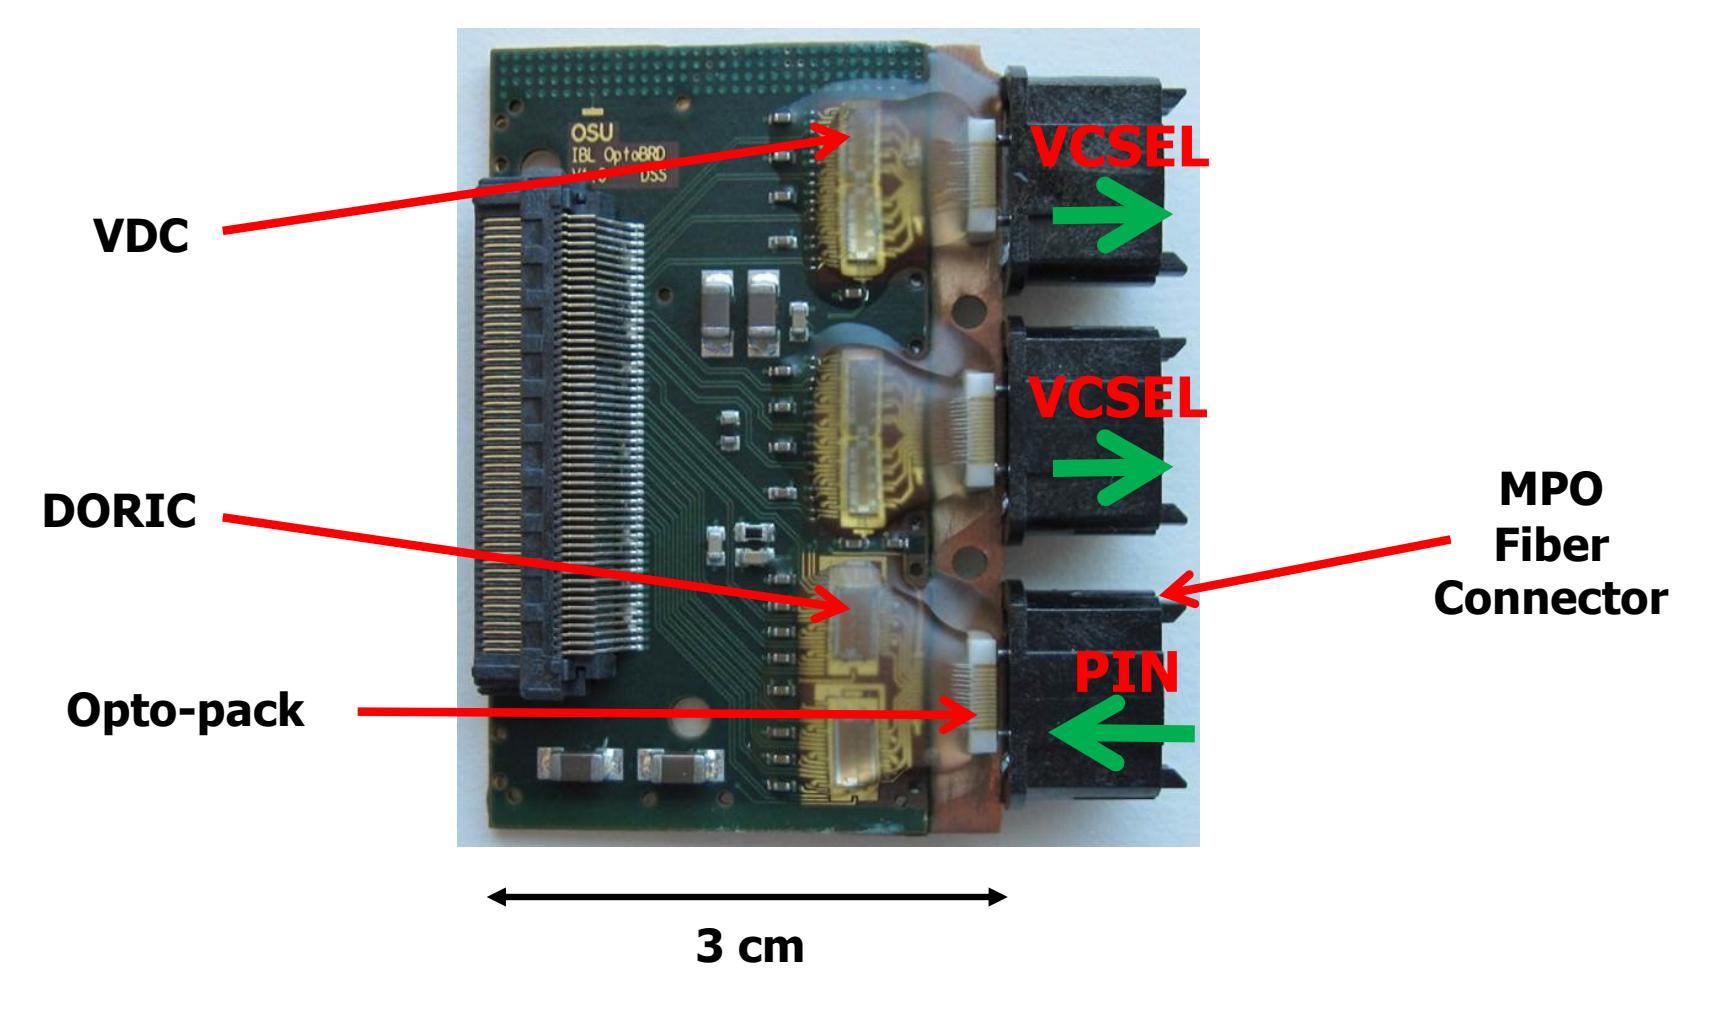
Opto-Board

- 63 out of 2620 VCSELs have failed (2.3%)
 - opto-box in dry environment
- no failure in 448 VCSELs of IBL
 - opto-box in N₂ environment/much higher radiation
 - probability of observing no failure is 2.5×10^{-5} ("4.0 σ ")
- VCSELs survived over 2,000 hours in accelerated aging:
 - 85 C/85% relative humidity
 - industry standard is 1,000 hours
- premature dead not understood

- produce 400 new opto-boards
 - 272 boards are needed
 - IBL boards will not be replaced
- sealing the opto-box to reduce humidity
 - opto-boxes were supposed to be flushed with dry air
 - valves were not open
 - no sure when valves were closed

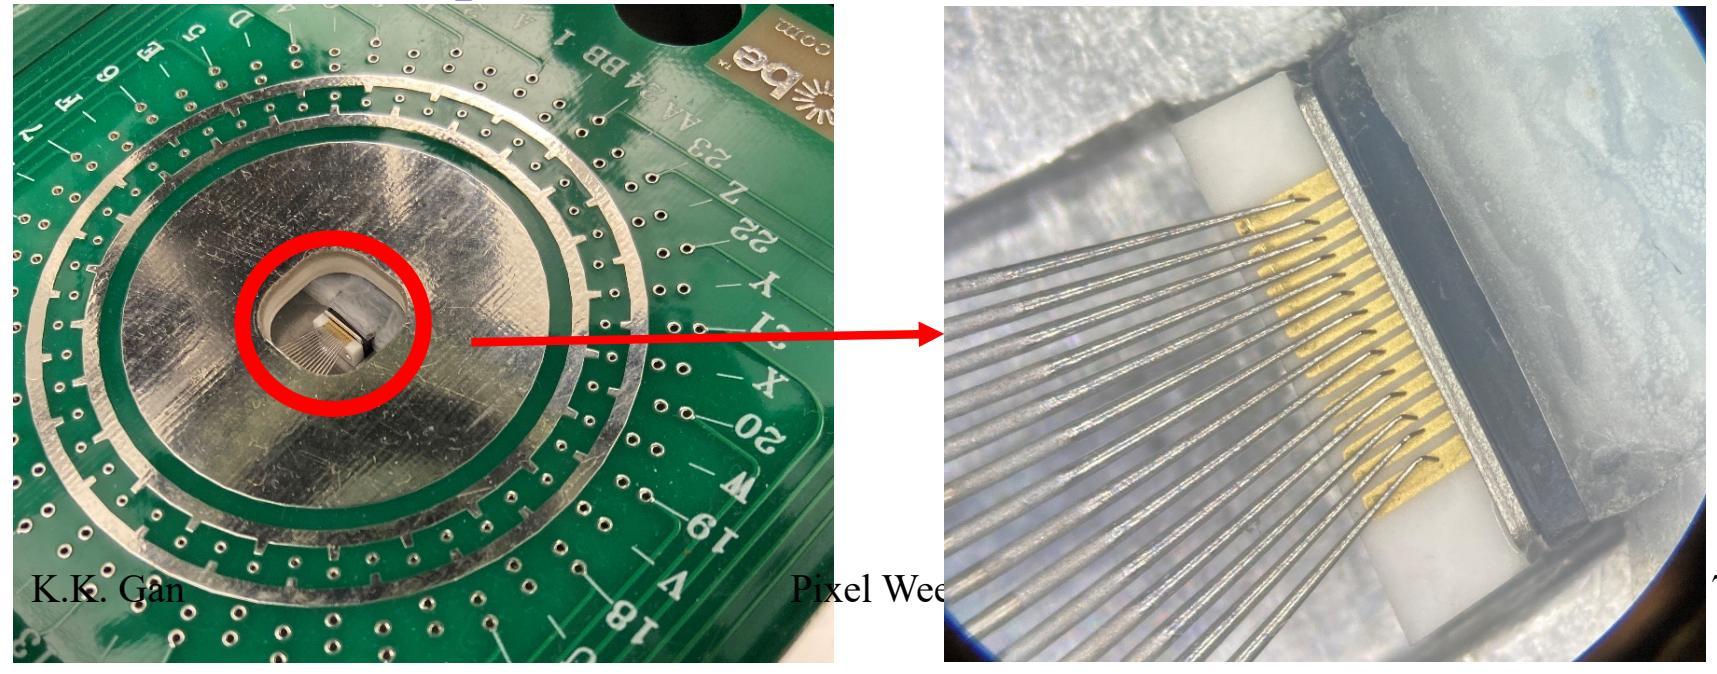
Opto-Pack Production

- each opto-board contains three opto-packs
 - each opto-pack contains a VCSEL or PIN array
- no change in the opto-pack design
- new VCSEL manufacturer recommended burn-in
 - burn-in system with 15 probe cards have been setup
 - QA procedure to compare changes in device characteristics has been implemented

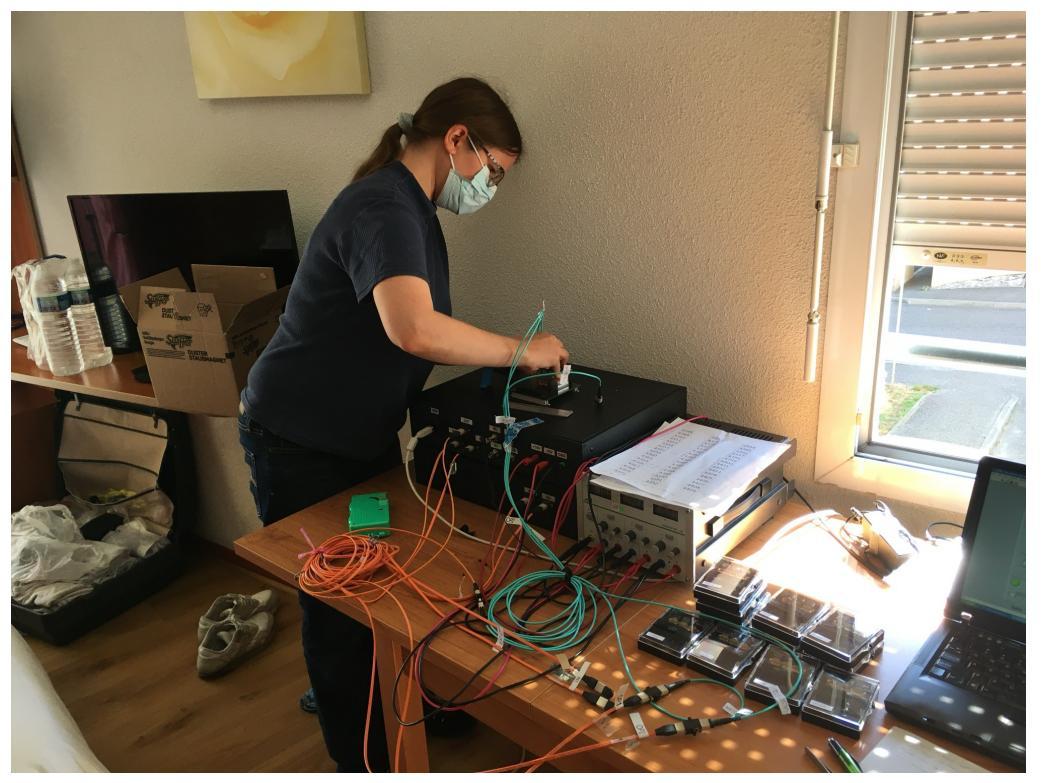
CERN Reception Test

- CERN reception test system resuscitated in July at St. Genis
 - **5**0 opto-boards were delivered and all passed reception test
 - 3 opto-boards with detached opto-connectors returned to Ohio State and repaired
- reception test system is now setup at SR1

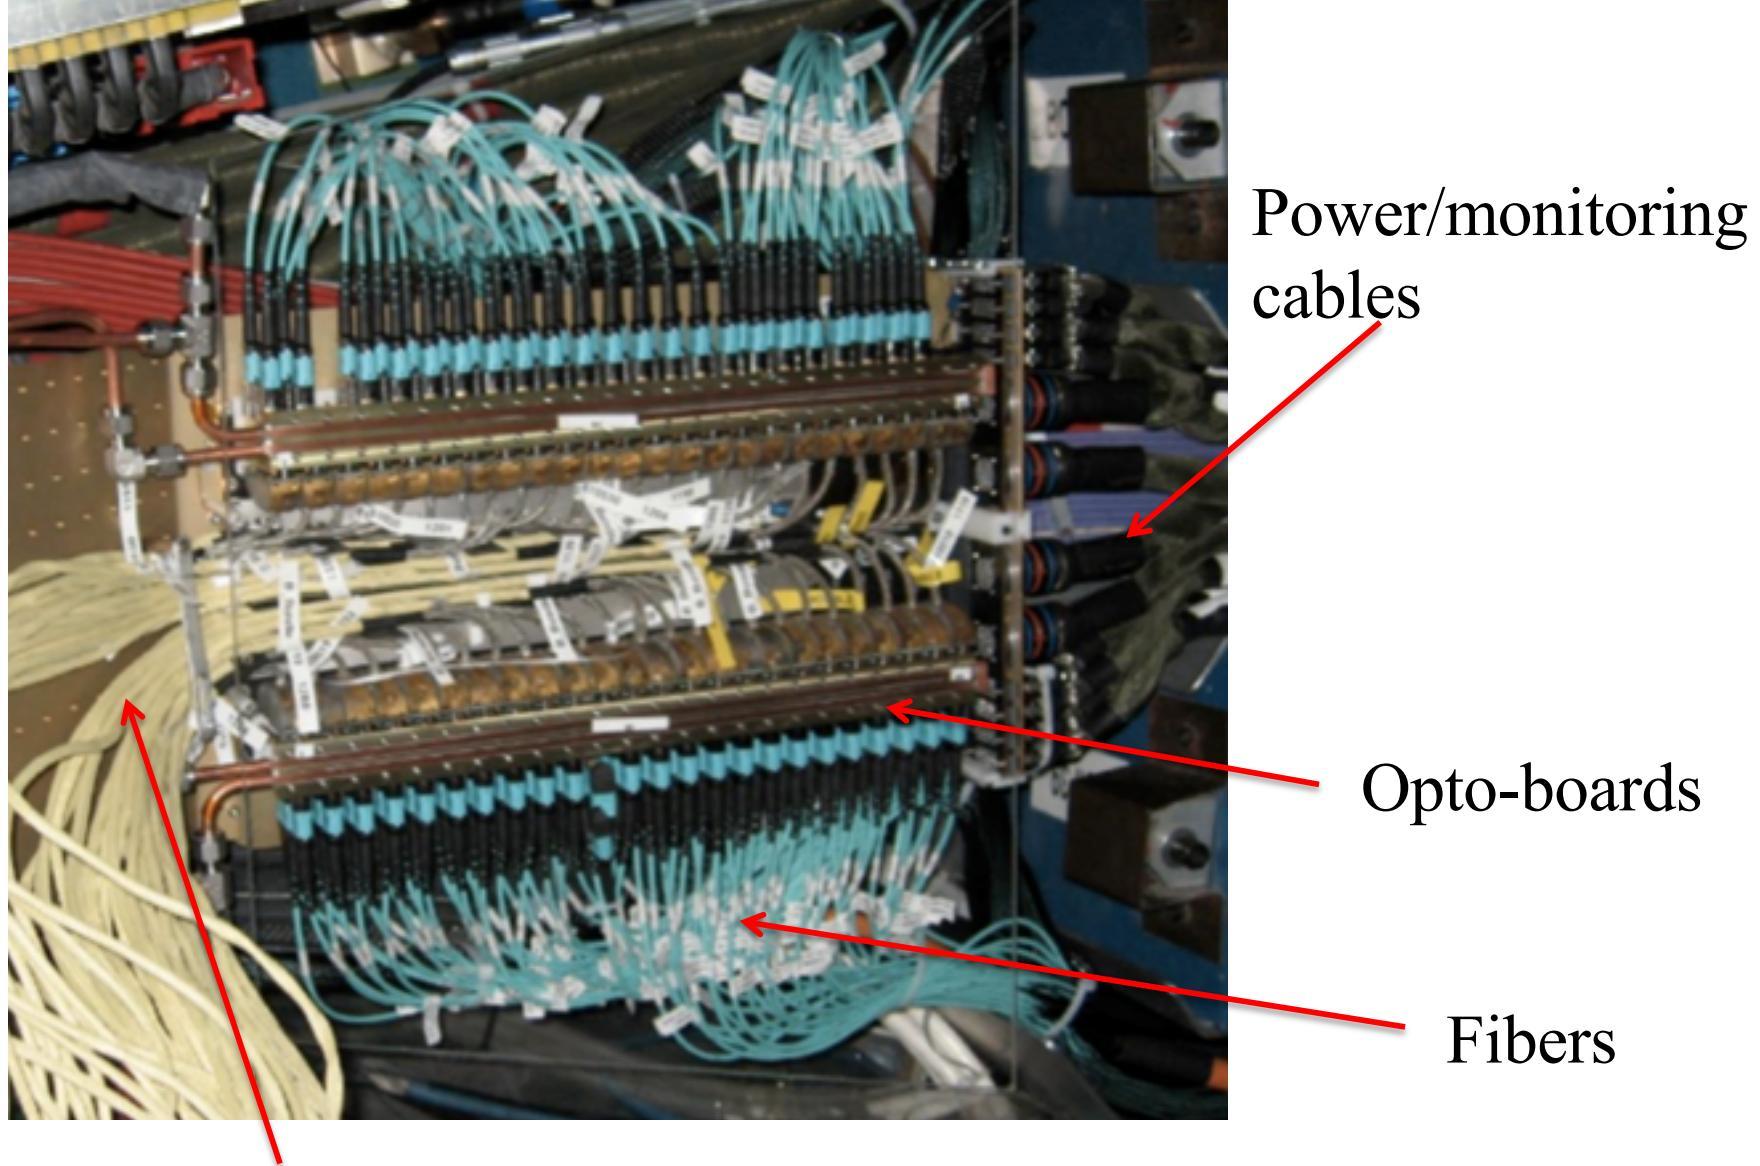
Opto-Box

- opto-boxes were supposed to be flushed with dry air
 - box is not air tight due to cables/fibers
 - ➡ improve sealing

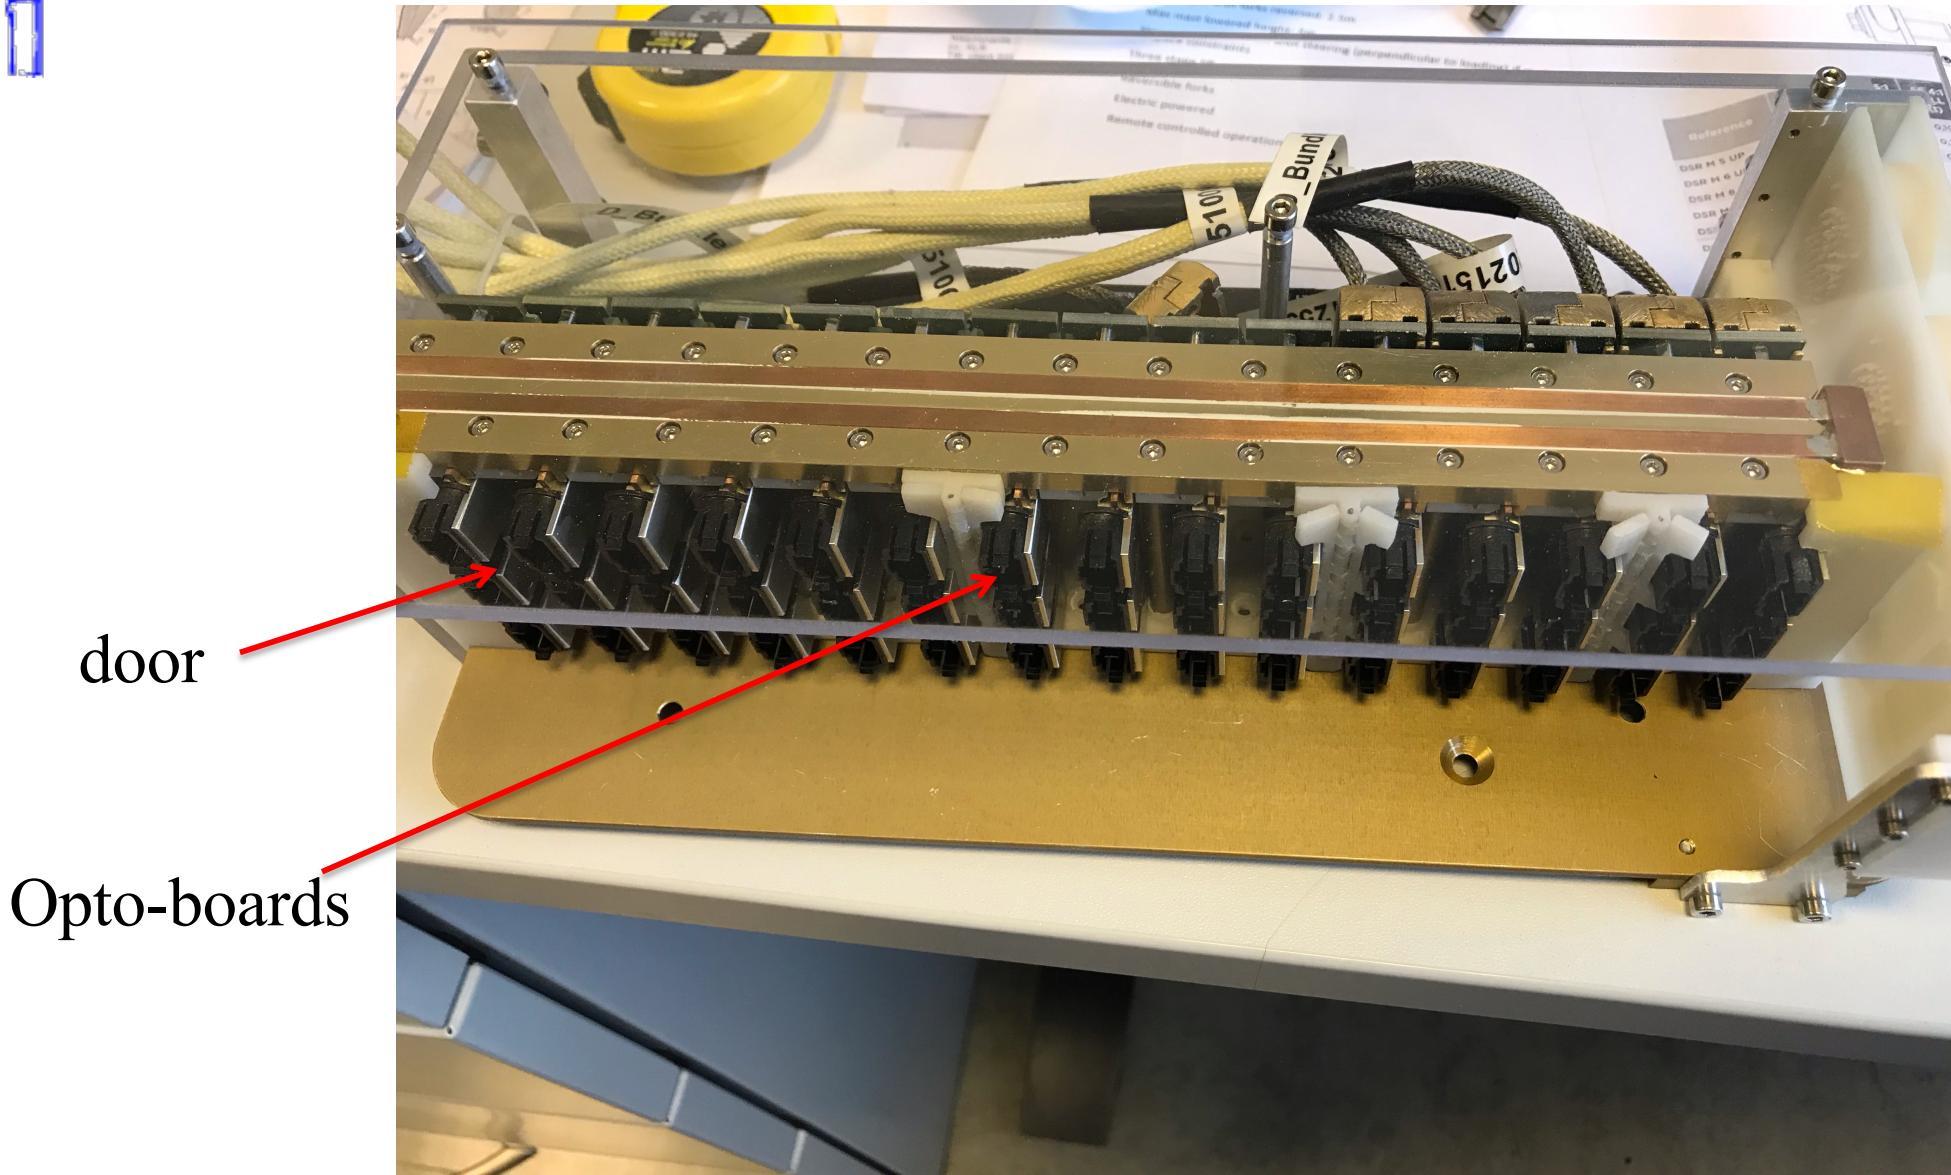
Partially Assembled First Prototype

- parts have been received and test fit
 - 3D printed box end board is working well
 - 2nd round of 3D printed doors don't fit that well
 - probably due to a change in the orientation of the print
 - ◆ acceptable tolerances have been specified
 ⇒ should fix the issue.
 - 3rd round is scheduled to be finished on November 10th
- climate chamber has been serviced and is being characterized
- once the new parts are fitted
 - characterize the sealing performance of the opto-box in terms of humidity vs. flow rate of dry air
