# Results of VCSEL Failure Investigations and Qualifications

B. Cote, K.K. Gan, H. Kagan, Z. Pollock, S. Smith, C. Tandoi, B. Tar, A. Woyshville  
The Ohio State University

June 3, 2019

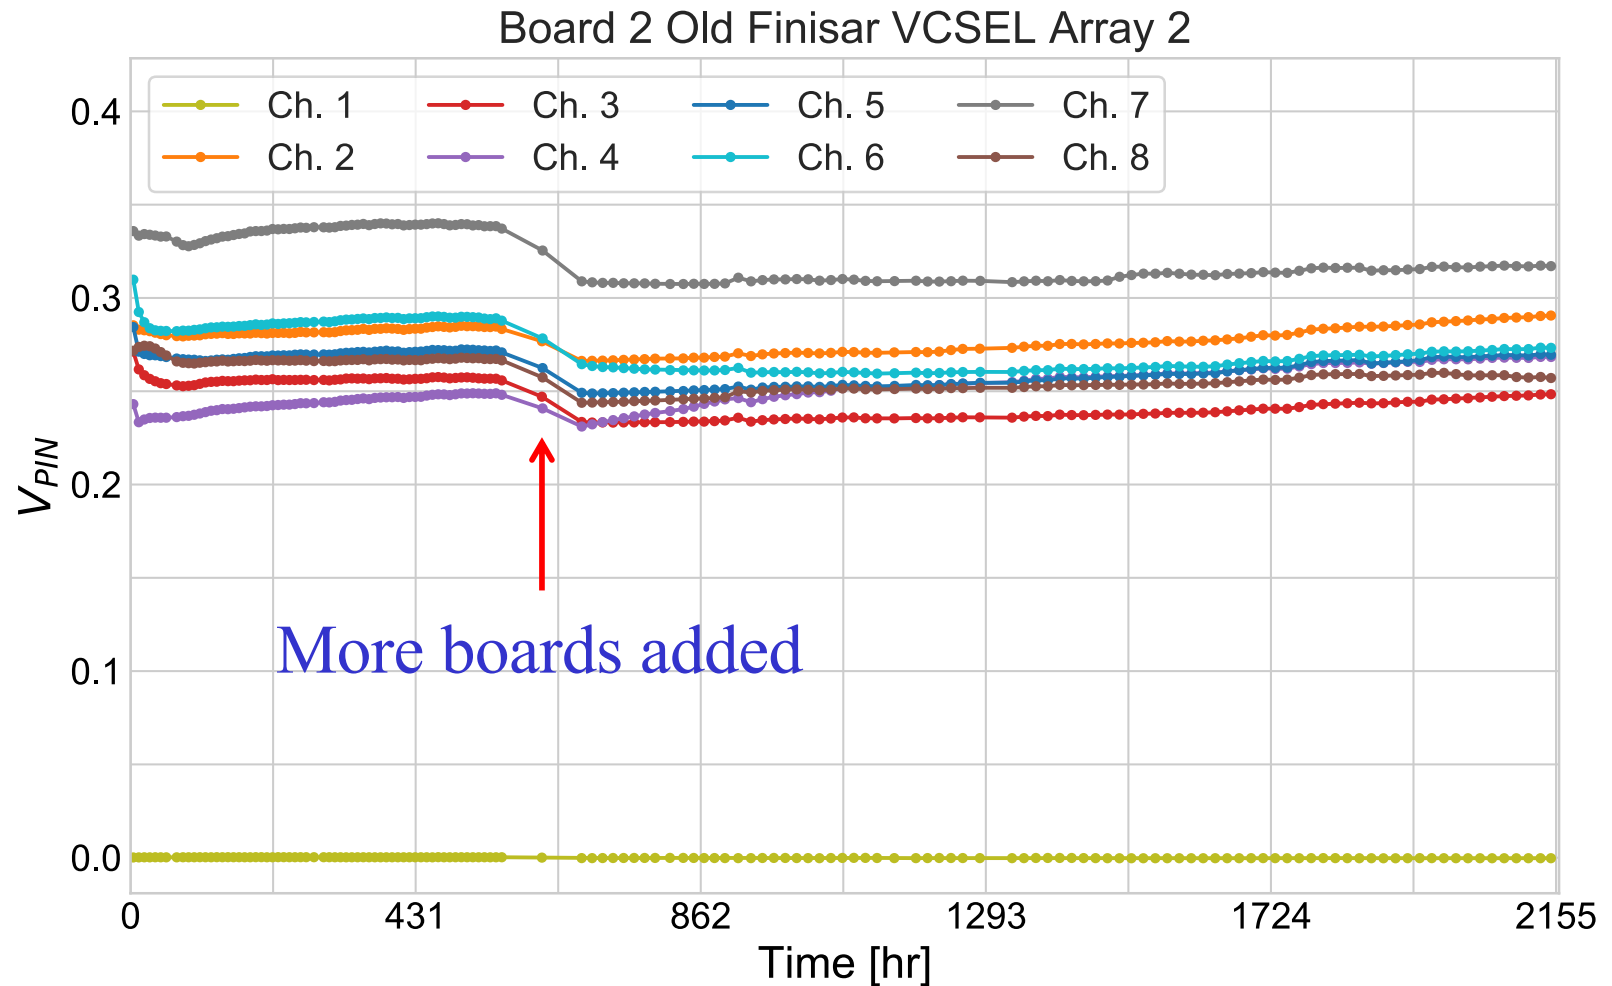
# Optical Power vs. Time (Burst)

- accumulated 2100 hours of operation at 85 C/85% RH
  - no VCSELs have died yet...
  - no difference between burst vs. clock operations
  - is humidity the cause of failure?
  - EAG believes the failure is due to humidity but Finisar would not confirm it
  - EAG did electron energy loss spectroscopy (EELS) with aberration corrected scanning transmission electron microscopy (ACSTEM)

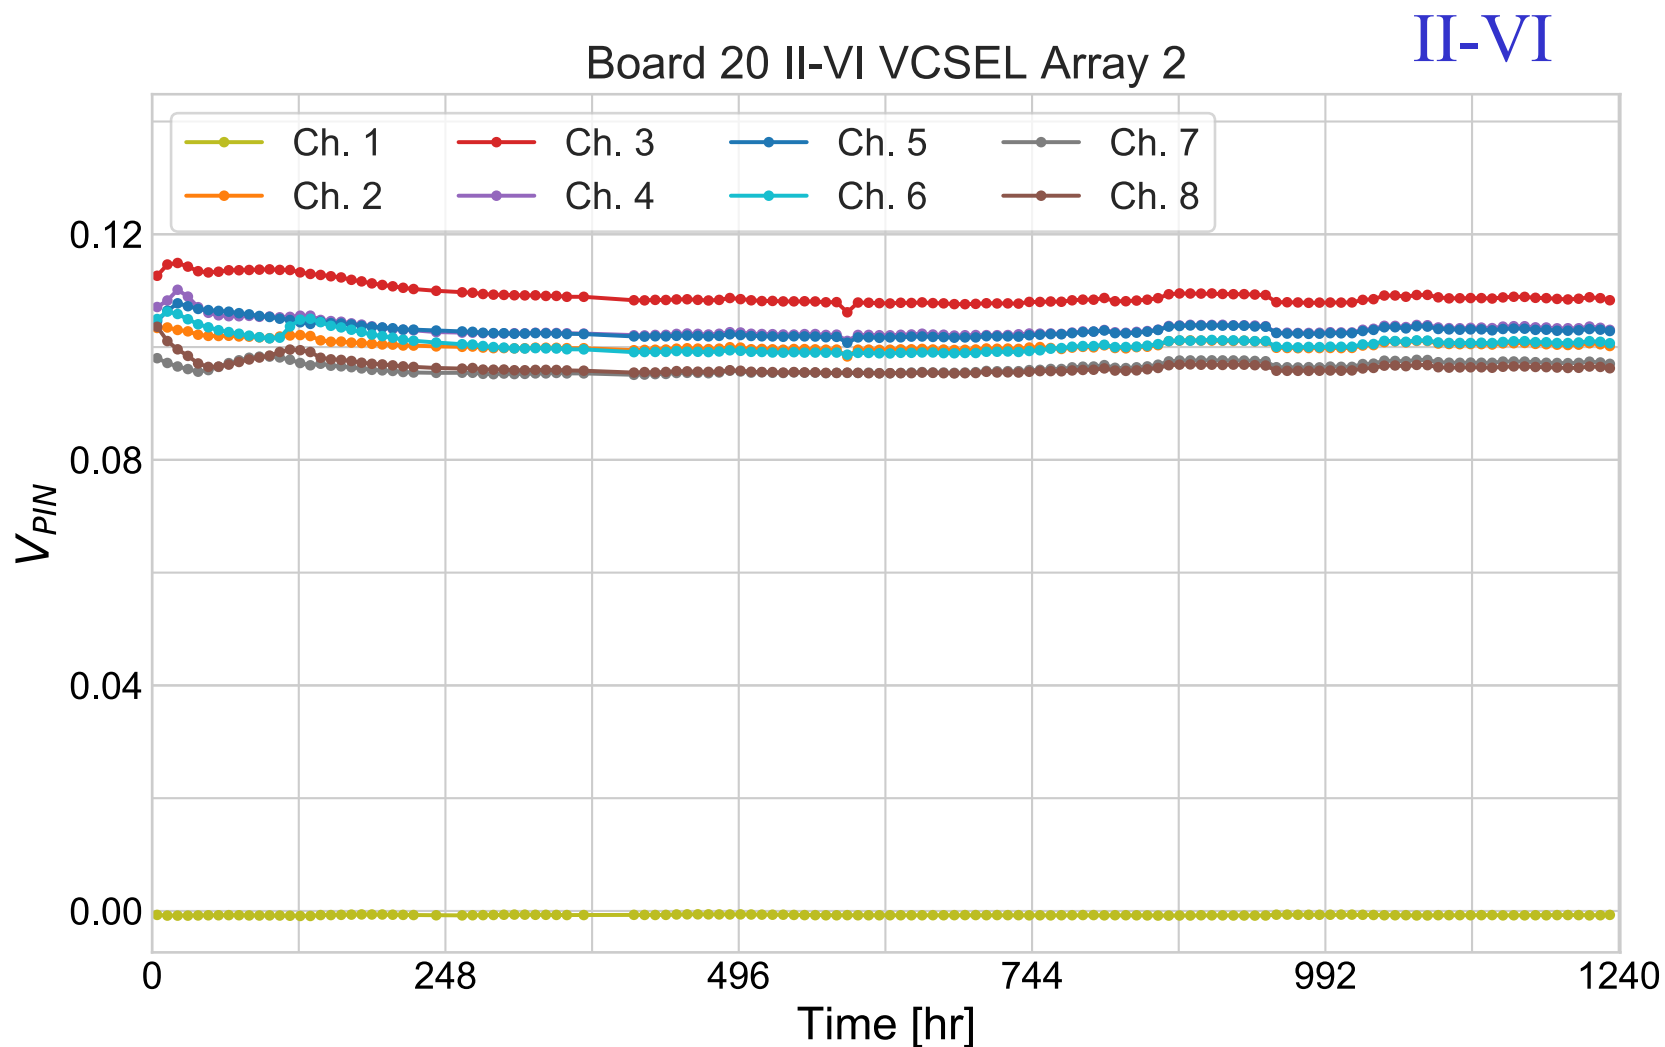
# 85/85 Test on Irradiated Boards

- opto-boards with VCSEL/PIN arrays from three vendors have been irradiated
  - good optical power at end of irradiation
- accumulated 1400 hours of operation at 85 C/85% RH for 4 Finisar + 4 ULM opto-boards
- accumulated 1200 hours of operation at 85 C/85% RH for 4 II-VI opto-boards
- 1 ULM channel started to fail at ~140 hour
- 139 channels are still alive
  - 7 channels have connection problems which will be verified
