# New Results on Opto-electronics

K.K. Gan

The Ohio State University

June 12, 2001

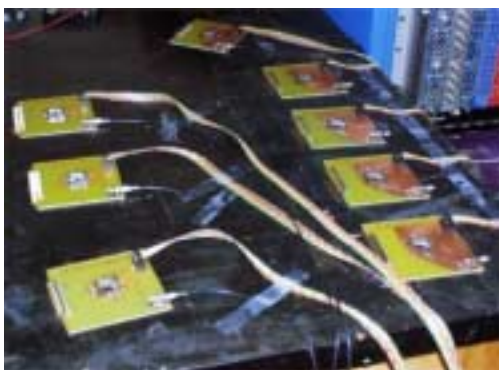
# Test Boards for Irradiation in Cold Box

3 VDC and 5 DORIC boards in test beam

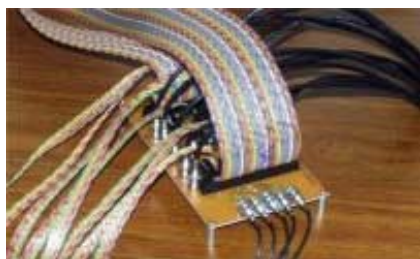
Repeater board for signal  
reshaping and routing

Bi-phase marked signal  
40 MHz LVDS signal

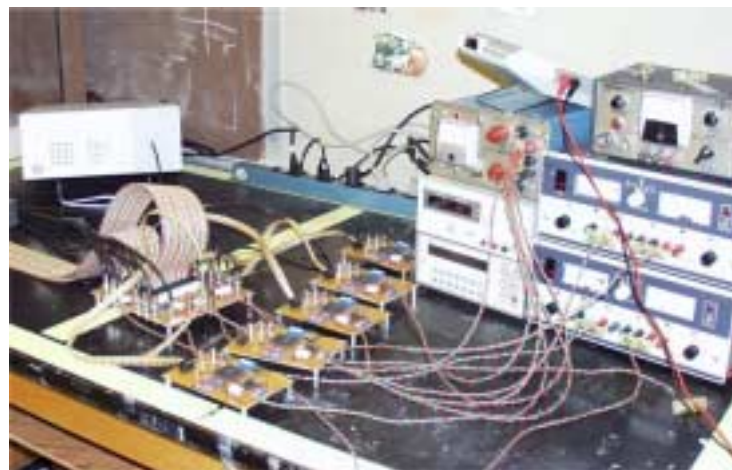
Bit error test board in control room

Decoded LVDS data + clock  
40 MHz signal
